HIPPOS - SUSSITA

Sixth Season of Excavations

July 2005

Conservation of Wall Plasters and Mosaic Floors in the NWC in 2005

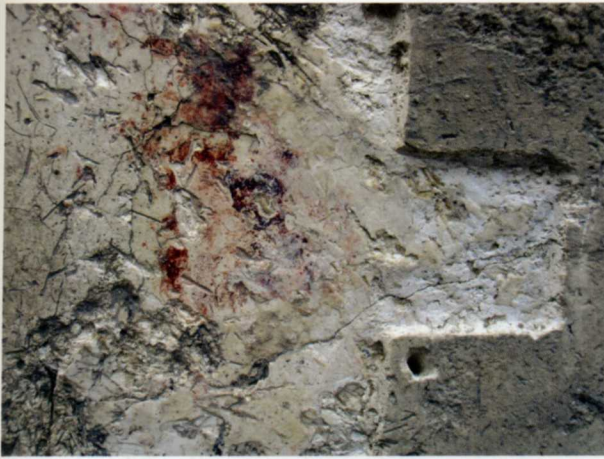
Stabilization treatments begun in previous seasons had to be continued also this year due to the bad state of preservation of wall plasters in this room. A number of injections were made to fill blisters and voids with liquid mortar. Edges of detached fragments were also protected with bands of lime-based mortar. Two weeks of work brought about a satisfying stabilization of the wall surfaces. Fragments of plaster with remains of yellow and red paint were carefully cleaned by removing salt blooms and thick dirt encrustations with the use of scalpel and a set of synthetic gums. Shallow probes revealed an earlier layer of decoration, but further examination of the whole structure proved that only some areas were covered with a second layer of plaster and painted again. (fig. 79)

Fig. 79, Hippos, NWC, the *martyrion* chapel, probes revealing remains of earlier painted decoration.

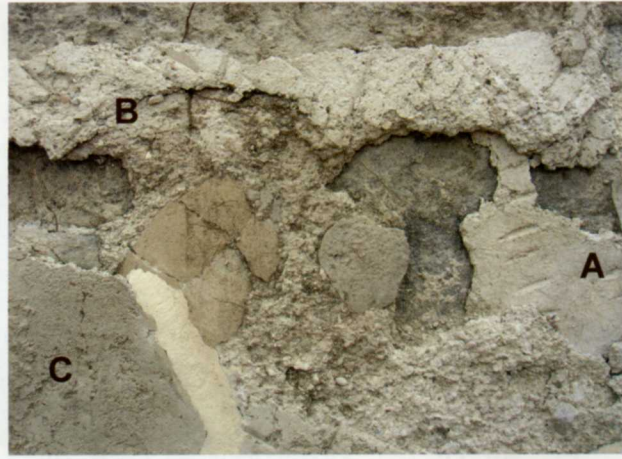
The pool was overlaid with a thin (ca. 1 cm) layer of hydraulic plaster of a very low quality. Under the plaster one can note a thick layer (ca. 1.5 – 3.5 cm.) of very soft and weak lime-based mortar containing crushed potsherds and pieces of organic substances. This lower layer was marked with incisions that were supposed to increase the adhesive properties of the plaster. Only the eastern wall of the pool had three layers of coating instead of just two. The additional lowermost layer, of very good quality and in excellent condition was laid directly on the basalt masonry and it was hatched as well. (fig. 80)

Both layers were in a very bad state of preservation; in most places they completely lost their adhesion to the pool's walls and to each other, and remained *in situ* only owing to the support of blocks and soil slaps. Broad and deep voids were found filled with soil and small stones, small roots caused many breakings, very low quality of plaster and careless construction of the western wall of the pool seriously weakened the whole structure.

Fig. 80, Hippos, NWC, collection vat of the winery, three layers of hydraulic plaster: [A] the lowermost one of good quality, [B] thick layer containing crushed potsherds, [C] thin external coating. Note hatches on layers [A] and [B]

Emergency treatment included protecting the detached fragments with strips of cotton fabric glued to the surface, cleaning the voids and blisters, fixing and strengthening the edges with bands of lime-based mortar. Injections of liquid mortar were made very carefully and the process took much time due to the fact that weak and fragile plasters with large voids underneath would not be able to receive too much mortar at one time. The work in the pool was completed and had a satisfactory effect only on the steps descending into the collector. The remaining area has been temporarily protected and its condition still needs to be stabilized during the next season. (fig. 81) Poor remains of hydraulic plaster on wine press platform were also protected with bands of lime-based mortar and with filling up the gaps.

1. Removing of temporary protection of the wall plaster in the collecting vat of the winery and completing treatments begun in previous season, such as the reinforcement of extant plaster edges with bands of the lime-based mortar, as well as the consolidation of all layers of the wall plaster by injecting the liquid lime-based mortar. Strengthening of the structure of the vat's western wall may prove to be necessary to ensure plaster stability.

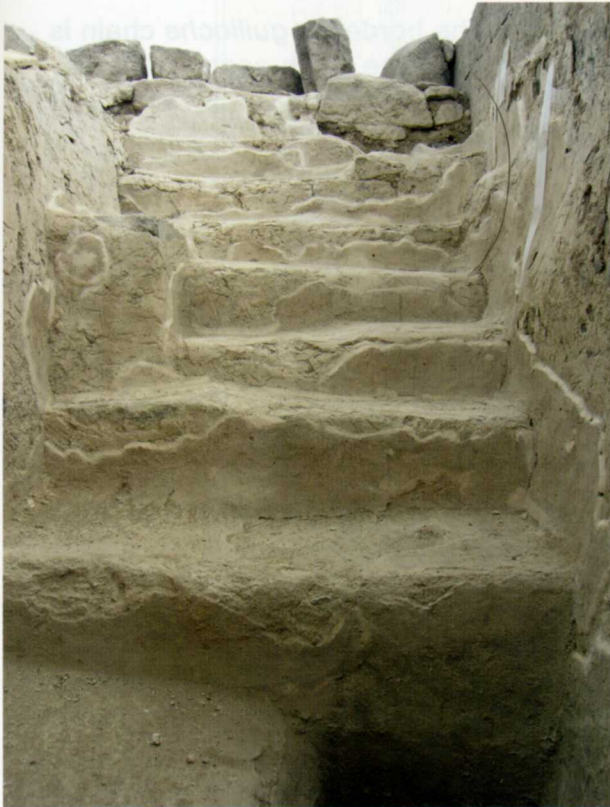
Fig. 81, Hippos, NWC, collection vat of the winery, steps descending to the pool. State after basic stabilization treatments.

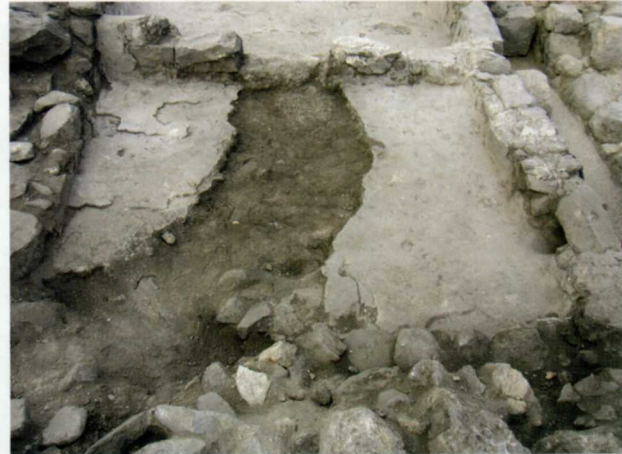
Two shallow plastered pools were exposed only on the last day of the season and therefore had to be left till next year without any immediate intervention, but the state of preservation of their plaster is quite good and there is no real danger of it sliding down. (fig. 82)

Fig. 82, Hippos, NWC, one of two storage compartments of the wine press complex. Note the plaster coating damaged by the IDF trench.

2. Conservation works in two storage compartments of the wine press by applying the same treatments as those previewed for the collecting vat: the consolidation of detached fragments and the protection of plaster edges.

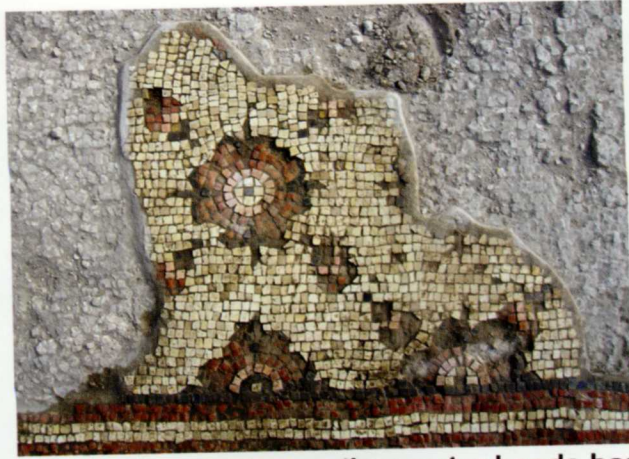
Fig. 83, Hippos, NWC, The nave. Setting up the mortar bands has stopped the "domino effect" - i.e. the crumbling up of the tesserae and gradual decreasing of the floor area.

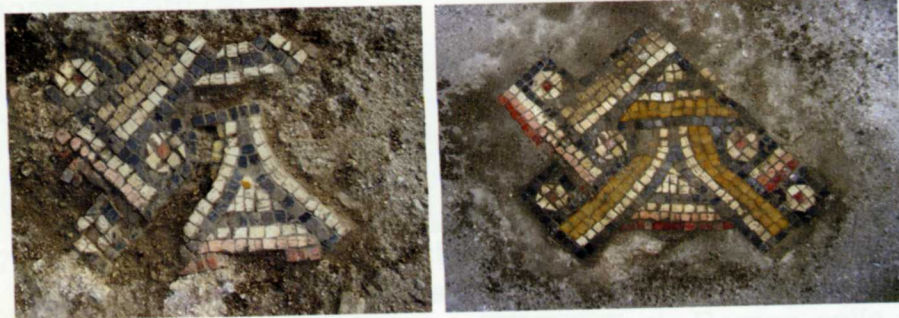
Fig. 84, Hippos, NWC, The nave. Reconstructed part of the border: a *guilloche* chain is the only fragment of the floor which has remained in the north-east part of the nave.

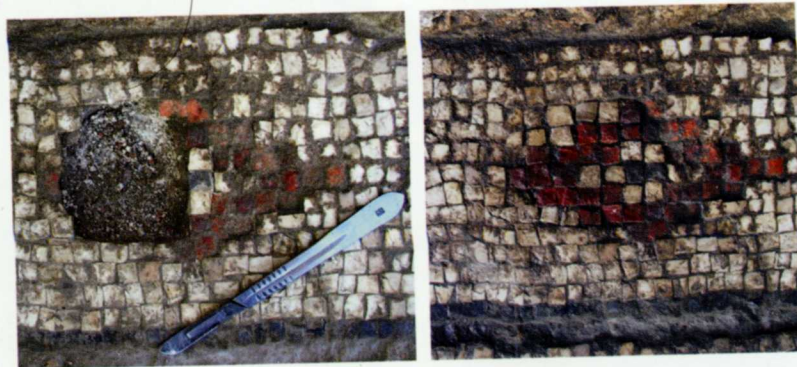
Fig. 85, Hippos, NWC, The presbytery. Reconstruction was made possible due to a clear arrangement of the *tesserae* and the recurrence of the pattern.

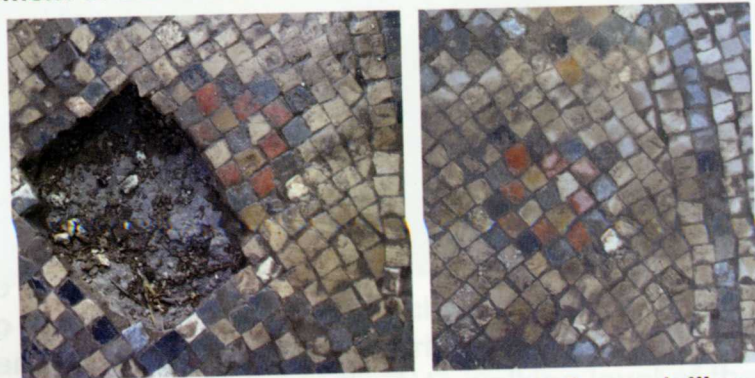
Fig. 86, Hippos, NWC, The northern annexe. A part of a medallion, situated in the central part of the room, was renovated.

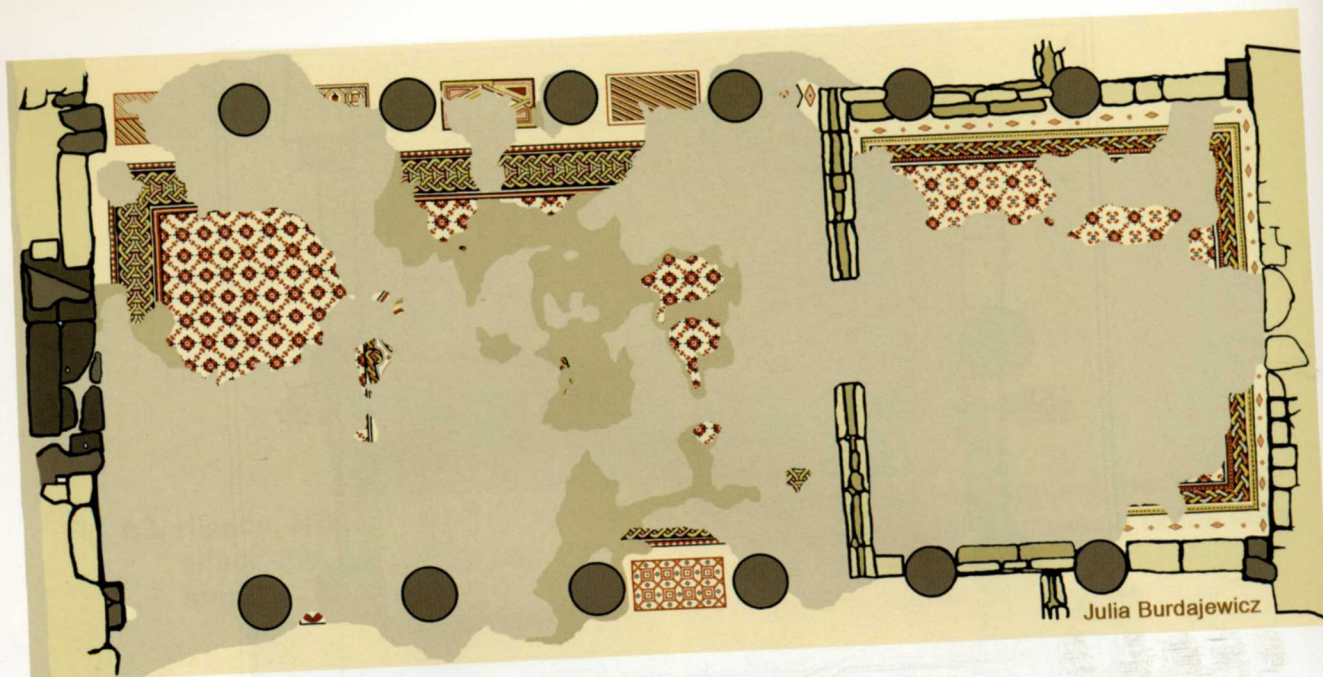
Fig. 88, Hippos, North-West Church, plan showing patches of extant mosaic pavement in the nave. Dark gray colour marks the range of preserved mosaic bedding [drawn by Julia Burdajewicz].
