HIPPOS - SUSSITA

Sixth Season of Excavations

July 2005

University of Haifa

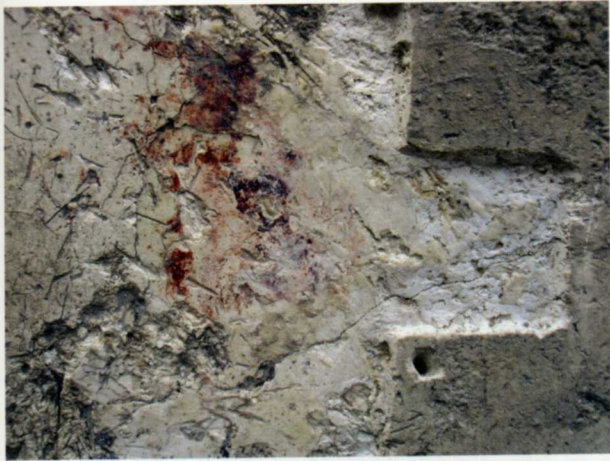
Fig. 79, Hippos, NWC, the *martyrion* chapel, probes revealing remains of earlier painted decoration.

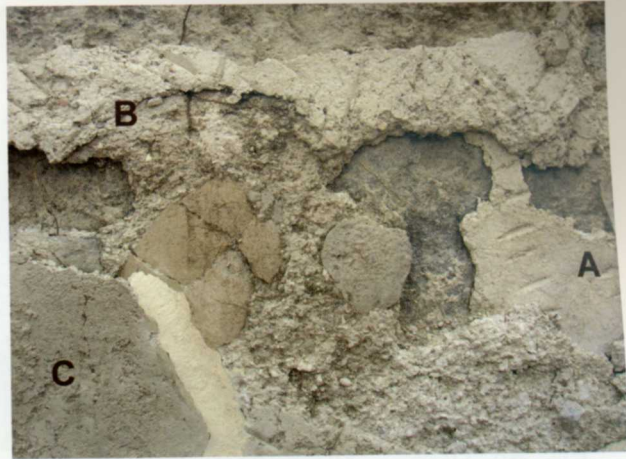
Fig. 80, Hippos, NWC, collection vat of the winery, three layers of hydraulic plaster: [A] the lowermost one of good quality, [B] thick layer containing crushed potsherds, [C] thin external coating. Note hatches on layers [A] and [B]

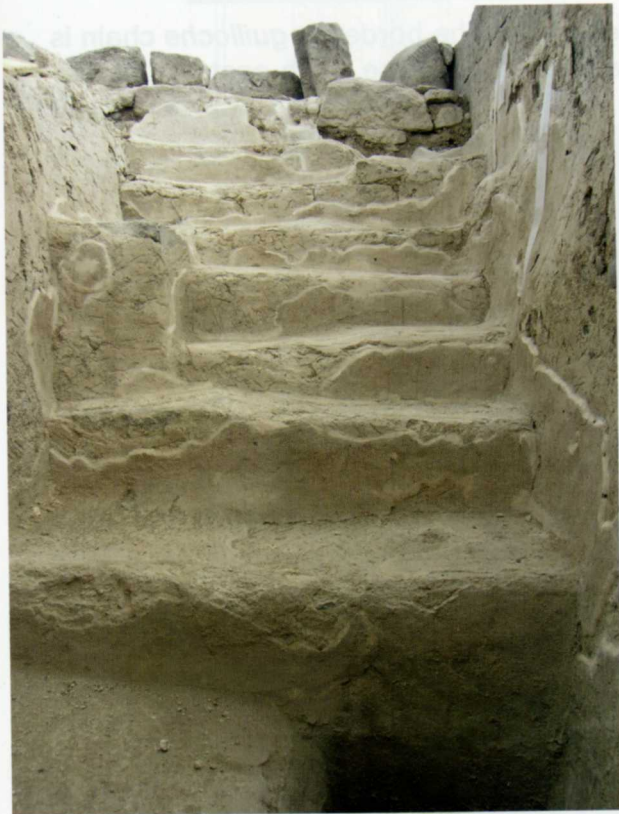
Fig. 81, Hippos, NWC, collection vat of the winery, steps descending to the pool. State after basic stabilization treatments.

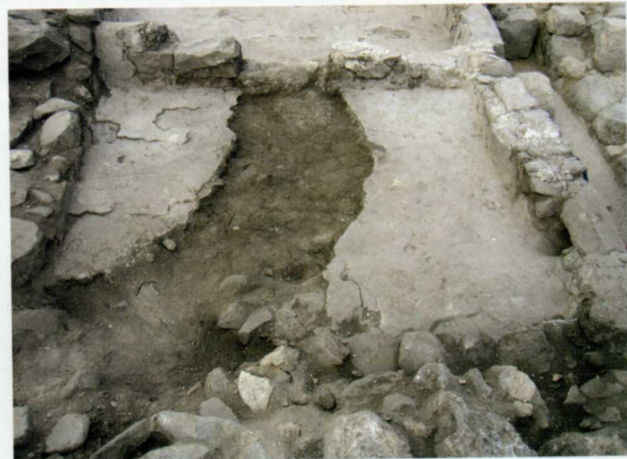
Fig. 82, Hippos, NWC, one of two storage compartments of the wine press complex. Note the plaster coating damaged by the IDF trench.

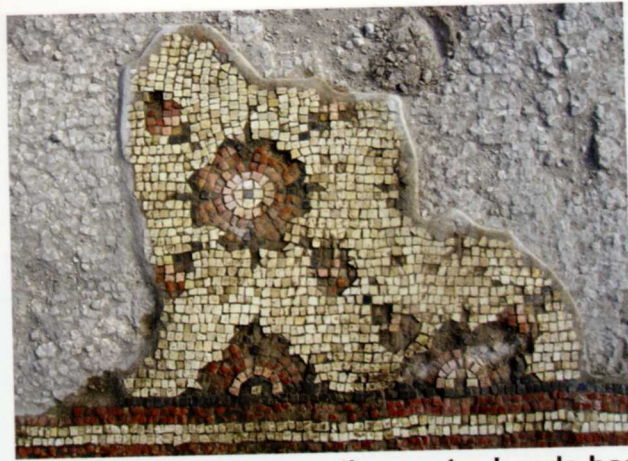
Fig. 83, Hippos, NWC, The nave. Setting up the mortar bands has stopped the "domino effect"- i.e. the crumbling up of the tesserae and gradual decreasing of the floor area.

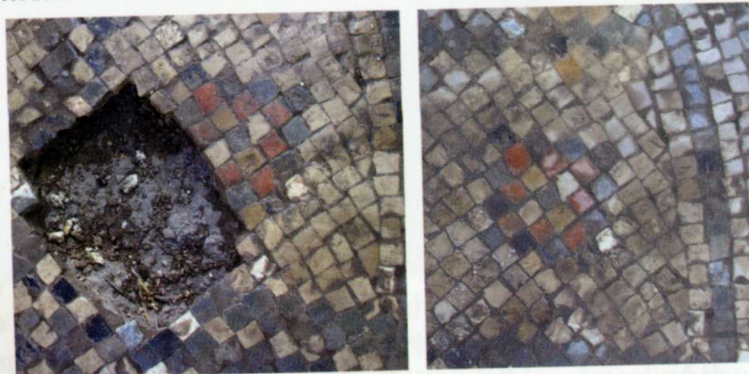
Fig. 86, Hippos, NWC, The northern annexe. A part of a medallion, situated in the central part of the room, was renovated.

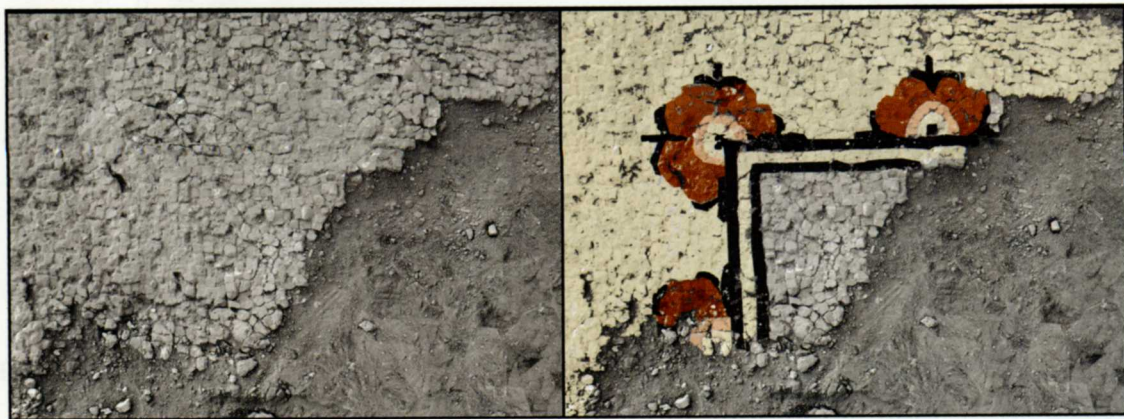
Fig. 89, Hippos, North-West Church, analyzing imprints of *tesserae* on the bedding of lime-based mortar: defining a corner of the central panel.

The examination of the tesserae imprints on preserved bedding fragments confirmed this hypothesis and allowed us to reconstruct both the extent of the panel and the general design of its pattern. After defining the corners of the panel by analyzing the tesserae imprints on the bedding (fig. 89), it became clear that the dimensions of the central field were 3.14 by 3.05 m. The medallion was composed of interwoven two-strand *guilloche* and a sort of diamond stripe (fig. 87). This kind of interlacement must have created eight smaller circles and, most likely, a large circle in the centre of the medallion. Similar composition is found in a building at Beit Gemal/Khirbet Jiljil (5th century?),¹⁹ in the northern aisle of St. George church in Houad, Syria (second half of 6th century),²⁰ and in the lower church of Kaianus in 'Uyun Musa Valley in Jordan (early 6th century).²¹ However, the closest parallel comes from the above-mentioned church of Khirbet Moûqa in Syria, where it adorns the western of two panels (4.0 m by 4.40 m. each) in the nave. The small circles in the Syrian example are filled with bird representations. Unfortunately, it will remain unknown what motifs were filling the corners and the circles of the central composition in the North-West Church. Taking into consideration general stylistic trends of the floor decoration during the second phase of the church, it is most likely that geometrical or simple vegetal motives were used there. In the central field of the medallion, a commemorative inscription might have been inserted.
