HIPPOS - SUSSITA

**Seventh Season of Excavations
July 2006**

Conservation Work in the North-West Church Complex

Julia Burdajewicz

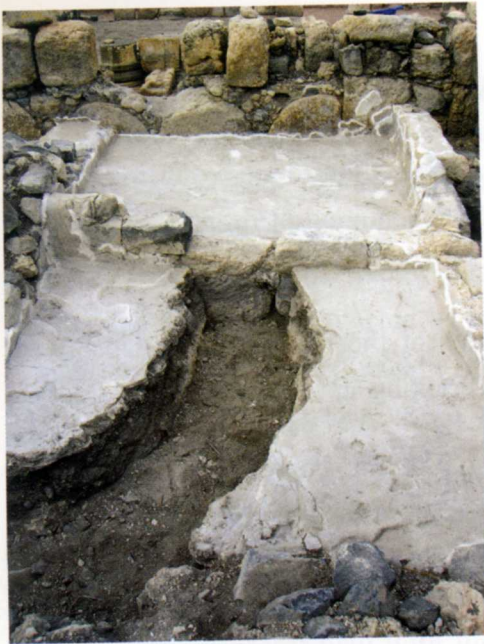
Conservation action in the winery began from the twin plastered compartments for storing grapes (L782-783). Since these compartments were unearthed only during the last days of the previous (2005) season, they had to be left virtually without any protective intervention. However, due to a fairly good quality of their plaster revetment, no serious plaster losses were recorded over the past months. Stabilization treatments conducted there in 2006 included strengthening of the broken plaster edges with bands of lime-based mortar as well as applying a number of glue injections (Primal AC-33). As a result, the preservation state of the plaster lining has been estimated as satisfactory; it is only in the northern compartment (L783), which was partly destroyed by a military trench, that a danger of partial plaster loss on the edges of the modern trench has not entirely been eliminated (see fig.1).

Fig. 1, Twin plastered compartments for storing grapes in the winery in northern wing of North-West Church. State of preservation after treatments conducted in 2006 season. Note military trench in the northern compartment.

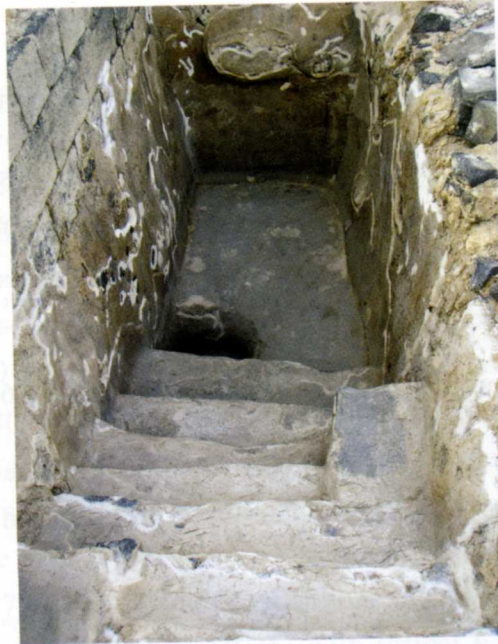
Stabilization treatments begun in 2005 season inside the wine collection pool (L776) had to be continued during the season of 2006 as well. Numerous voids and blisters recorded on the surface of the hydraulic plaster coating the walls were cleaned and consolidated with the use of a liquid mortar based on hydraulic lime, while the plaster edges were being fixed and reinforced by means of bands of lime-based mortar. The whole process was complex and time-consuming due to the fact that the pool coating

consists of as many as three layers of plaster differing in quality and thickness. Also the fragility of plaster layers, with big blisters hidden underneath, prevented us from injecting too much mortar at one time. These treatments need to be continued also during the next season (see fig. 2). Finally, poor remains of hydraulic plaster surviving on the walls of the wine press platform (L775) and the fermentation room (L210) were cleaned and protected by applying lime-based mortar bands.

Fig. 2, Collecting vat in the northern annexe of the North-West Church. State of preservation after the conservation treatments applied in 2006 season.

- Completing of the stabilization treatments in the collecting vat of the winery begun in previous seasons: consolidation of detached fragments and protection of the edges.
- Checking of the condition of plastered parts of walls treated during previous seasons and subsequent consolidation and strengthening actions on weakened or detached fragments wherever required.
- Recording and describing of any changes in the condition of the plaster that might have occurred since the end of 2006 season.
- Emergency work following exploration of new areas wherever required.

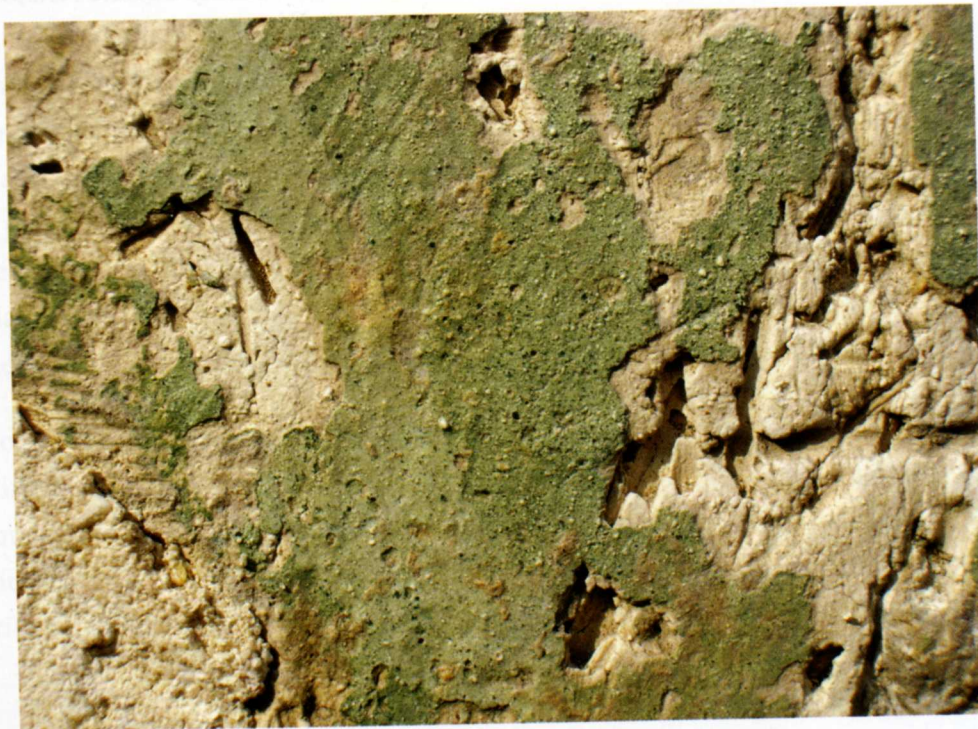
Five drums (NWC06 – 11) and five column capitals of basalt (NWC03 - 05, NWC16 – 17) uncovered in the *basilica* during the seasons of 2000-2001 and buried since then under an earthen mound, were re-exposed during this season and moved to a safe storing place by the northern entrance to the *atrium*. All these architectural elements were covered with remains of plaster. During routine cleaning and removing of a thick layer of dirt, a green applied colouring was discovered on columns' drums, and a red one - on capitals. The surface was cleaned using dental tools, scalpels and soft brushes, after which the coloured plasters were protected with 3% Paraloid B-72 solution in acetone (see fig. 3).

Fig. 3, Remains of green-coloured plaster covering columns' drums stored in the *lapidarium* by the northern entrance to the *atrium*. State of preservation after routine cleaning and removing of a thick layer of dirt (close-up).
