HIPPOS - SUSSITA

Eighth Season of Excavations

July 2007

Conservation Work in the North-West Church Complex

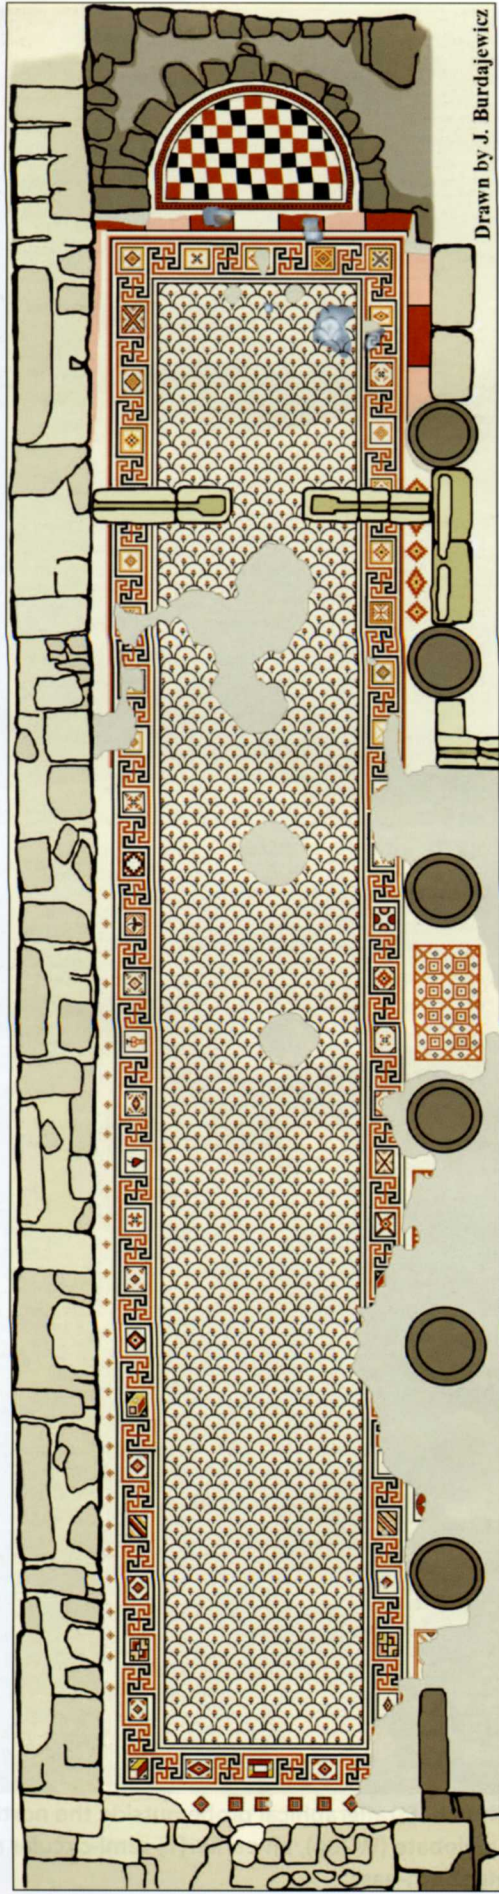
Fig. 111, Hippos 2007, North-West Church. Plan of the mosaic in the northern aisle of NWC. Gray colour shows areas of *lacunae* where basic stabilization treatments were conducted during previous seasons. Blue patches show areas of shallow depressions (down to 7 cm.) caused by impact of stones falling down during the earthquake.

Protection of the floor in question mostly included replacing of old mortar bands to the mosaics edges with the new ones. In preparation of the mortar bands, a ready-made lime mortar ("Ready Mix") was used, with addition of a sieved sand. Larger gaps have first been protected with bands, and then entirely filled with lime-based mortar. The mortar has been applied in two layers and leveled up to the mosaic surface in order to strengthen the whole structure.

All structural and surface conditions as well as results of the previous conservators' interventions have been described and recorded both as a text and as graphic documentation (fig. 111). Detailed study of patterns in the northern aisle of the basilica, which was made possible through its careful cleaning, shed light on the chronology and decoration concept of the mosaic floor. Shallow trial pits were made inside the large gaps existing in the aisle's mosaic floor in order to examine the structure of the floor and its bedding (fig. 114). It turned out that in all probability there was no earlier mosaic floor before the existing one.

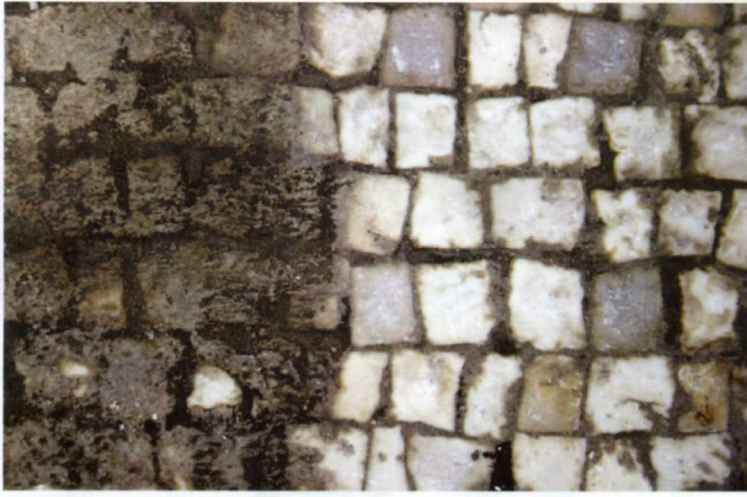
During the cleaning treatments it turned out that the yellow *tesserae* and some of the red ones, made of soft limestone, were severely affected by the erosion process. Most of them were successfully cleaned with a range of dental tools and afterwards protected with 1,5% solution of Paraloid B-72 resin in acetone and toluene applied by means of a small paintbrush. In some instances, however, dirt covering yellow cubes was so strongly attached to their surface that it was impossible to clean them quickly and effectively with methods available on the site, without affecting the *tesserae* themselves. Therefore, those cubes have been left with a thin layer of dirt upon them until complete and comprehensive cleaning process will be possible to conduct.

Fig. 112, Hippos 2007, North-West Church. View of plain fragment of mosaic in the northern aisle during the cleaning process. Left side: before, right side: after the removal of major amount of dirt (a close-up).

Protective layer of sand and fabric covering the floor of the northern aisle of the church was lifted during this season in order to record condition of the mosaic and any changes that might have occurred since year 2004 when it had been covered. Its state of preservation turned out to be very satisfactory and no traces of on-going destructive processes could be detected. Basic stabilization treatments applied during the previous seasons such as securing of the mosaic edges preserved the floor from further damages. Most of the *lacunae* within the area of the northern aisle have been located in its eastern part and clearly are the result of a collapse of heavy stone elements, which impaired the floor surface during the earthquake of 749 CE. Loss of the mosaic floor on the border between the aisle and the nave is likely connected to damages that occurred in the nave probably before the earthquake and extended towards the aisle due to “domino effect” that systematically decreases floor area. Small gaps may also be seen in front of the northern apsis and are traces of placement of the altar legs. In the same area, five shallow depressions mark the places where heavy stones hit the floor (fig. 111). The whole mosaic surface in the aisle was covered by a thick layer of compact dirt and probably calcium salt incrustations; actually, it had never been properly cleaned before. Wide range of cleaning methods, including the use of mechanical and chemical means,

was applied in order to enable preparing precise documentation of the patterns (fig. 112).

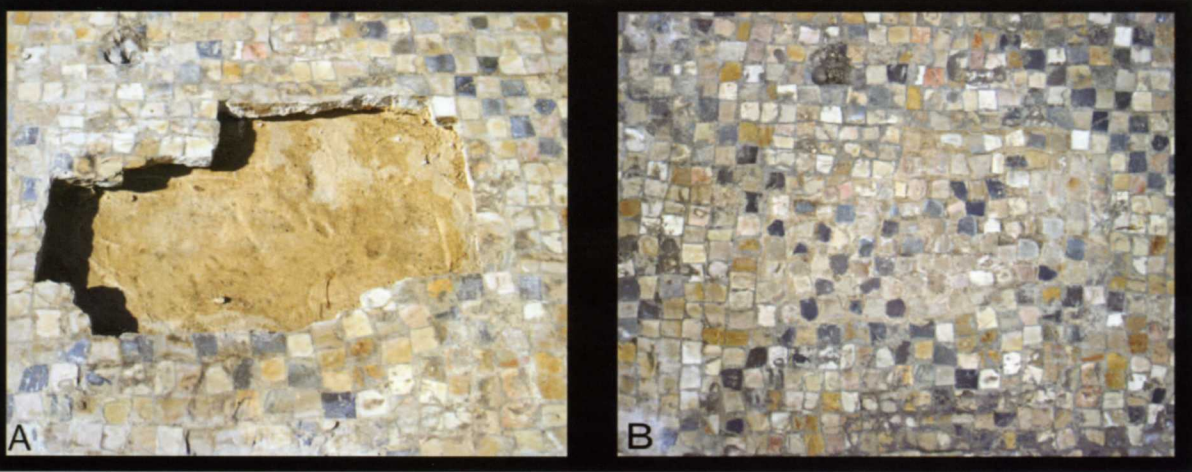
Fig. 113, Hippos 2007, North-West Church. Mosaic floor in the southern portico of the *atrium*: A. after dismantling a hollow in the mosaic and setting the first layer of a new bedding; B. the same place after restoring the decorative pattern with original *tesserae*.

Conservation works on the so-called "Antonia mosaic" in the southern portico of the *atrium* started with its discovery in 2004 season and included securing of the floor edges (especially the western edge, right above a trial pit that revealed a section of an Early Roman *temenos* wall, W157) as well as strengthening of the mosaic bedding by a series of glue injections (Primal E-330). The present condition of the mosaic can be described as stable and fairly good. However, as a result of collapse of heavy blocks during the earthquake of 749 CE, three depressions can be seen in the floor's surface. An original mortar of the mosaic has been strong enough and of rather good quality, thus the impact of falling stones didn't manage to crumble the mosaic but only pressed it into its bedding without breaking the structure. During the previous fieldwork seasons, all of the hollows were temporarily secured with bandage strips glued to the mosaic surface. In 2007, however, two spots in the mosaic floor that had been driven below its original surface were dismantled to provide a new bedding and to level the depressions. The bedding was prepared in two layers, both of them composed of a ready-made lime mortar, but with different fractions of added sand. Original *tesserae* were cleaned and

reused to restore the pattern (fig. 113). The third hollow, the largest one, was thoroughly cleaned and then reinforced with mortar bands, applied in small gaps on its edges.

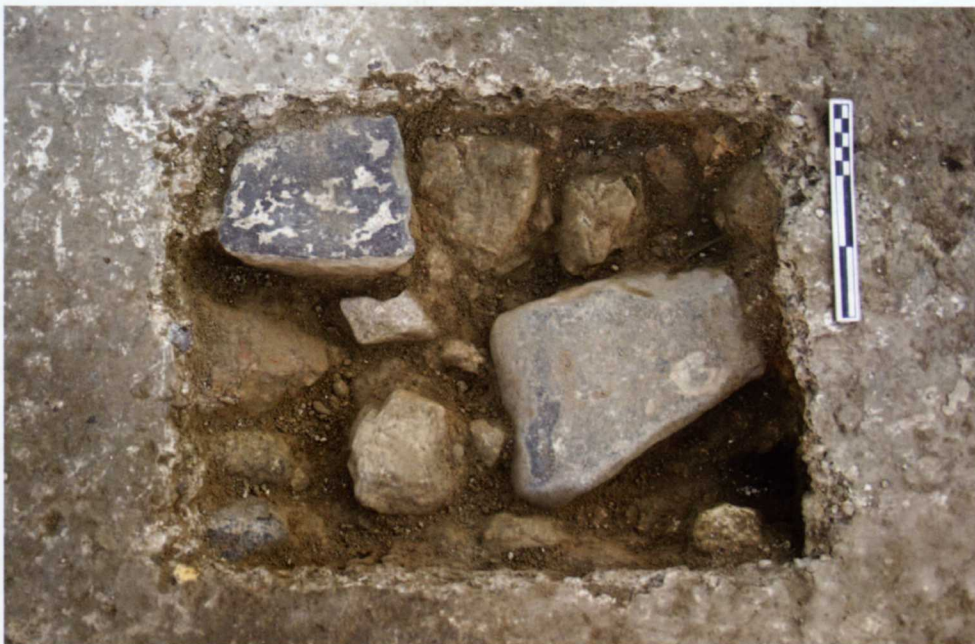
Fig. 114, Hippos 2007, North-West Church. Small trial pit within big *lacunae* area reveals the stone bedding (*statumen*) of the mosaic floor in the northern aisle.
