# 10<sup>a</sup> CONFERENZA DEL COMITATO INTERNAZIONALE PER LA CONSERVAZIONE DEI MOSAICI (ICCM)

LA CONSERVAZIONE: UNO STRUMENTO DI CONOSCENZA  
CONSERVATION: AN ACT OF DISCOVERY

## **HIPPOS (SUSSITA) CHURCHES REVEAL THEIR MOSAIC FLOORS**

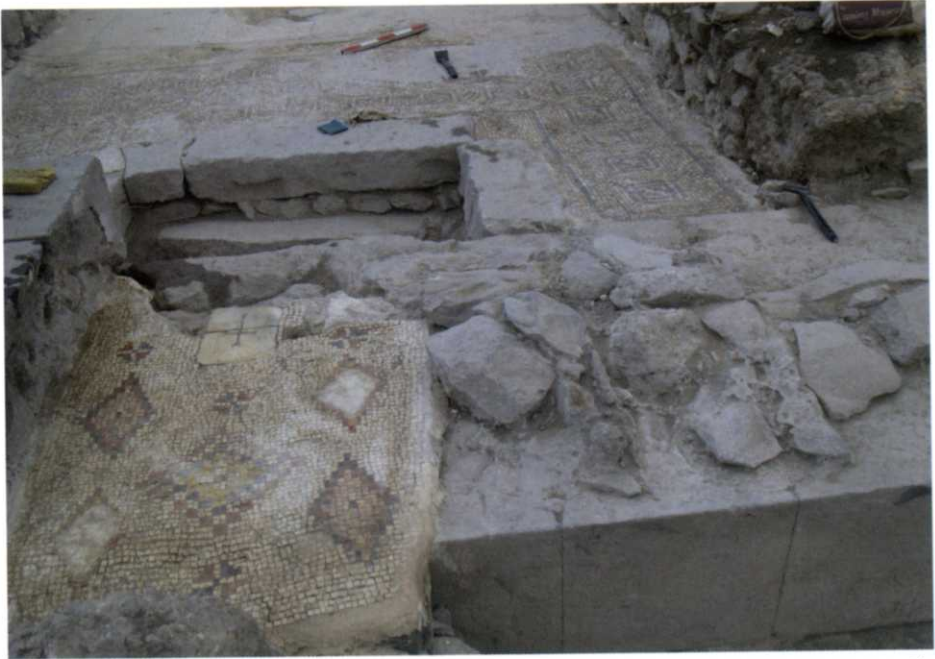
Fig. 2: *In situ* conservation of a mosaic above a Christian burial, overlying an earlier Roman wall.

As each time the conservation is limited to the area excavated during the four weeks of fieldwork, its main principle is to ensure an *in situ* protection through temporary conservation treatment (Fig. 2). Depending on the state of preservation, it is necessary to prepare a precise and individual plan of all the necessary treatments, and smoothly apply them to the mosaics. Preliminary activities include the unearthing and cleaning of the mosaic's surface in order to make it legible for documentation and for evaluating the degree of deterioration. Then all the fragments are reinforced by applying mortar bands to the edges, filling big lacunae with lime-based mortar and reconstructions of minor gaps with loose tesserae collected during the exploration. Finally, the strengthened mosaic pavement is re-buried (see below). All these activities are accompanied by a full descriptive and photographic documentation.

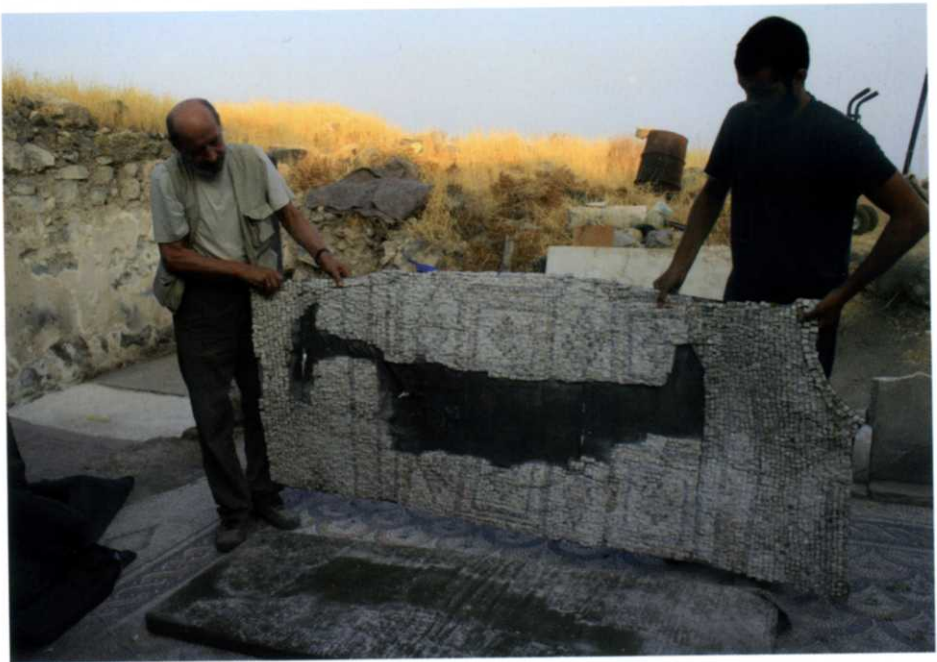
Fig. 3: The badly damaged part of the mosaic floor in South-West Church was lifted in order to be treated and to enable the exploration of earlier structures underneath.

The reasons for lifting a mosaic in the South-West Church were different. The relatively bad state of preservation of the mosaic floor of the southern aisle encouraged conservators to lift it in order to allow archaeologists to make a trial trench under the floor (Fig. 3). While a lifted section of the seriously damaged mosaic (c. 1 x 2 m) was undergoing treatment in the field laboratory, earlier floors and deposits were examined by the exploration team in order to determine the history of the building. After the archaeological investigation was completed, a new bedding was prepared according to the technique used for the original floor, and the mosaic was relayed in its initial position (Fig. 4).

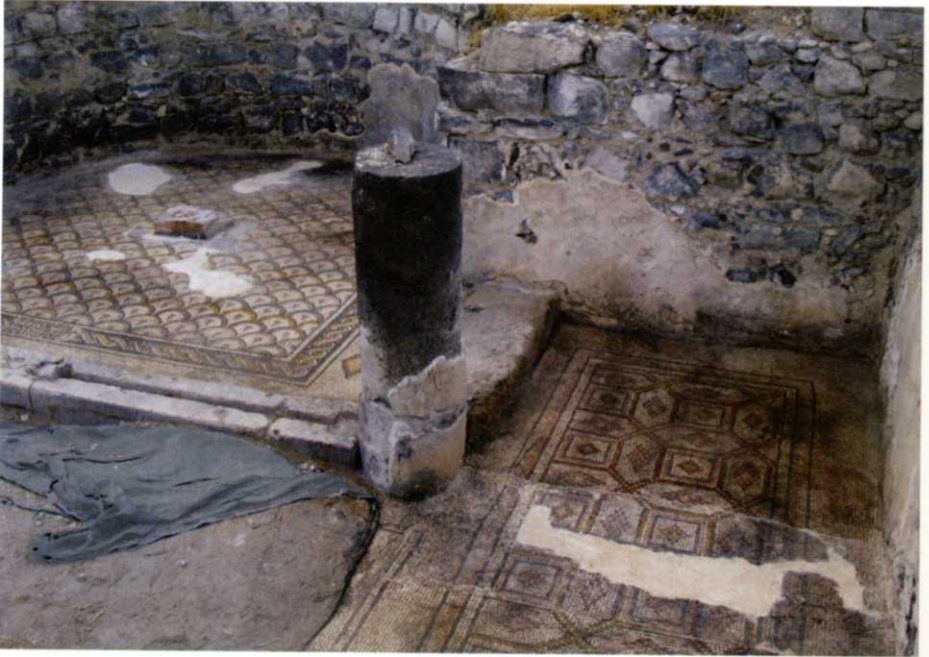
Fig. 4: Once the earlier layers were investigated, a new bedding was prepared and the mosaic was relayed in its original position in the south aisle of the church.

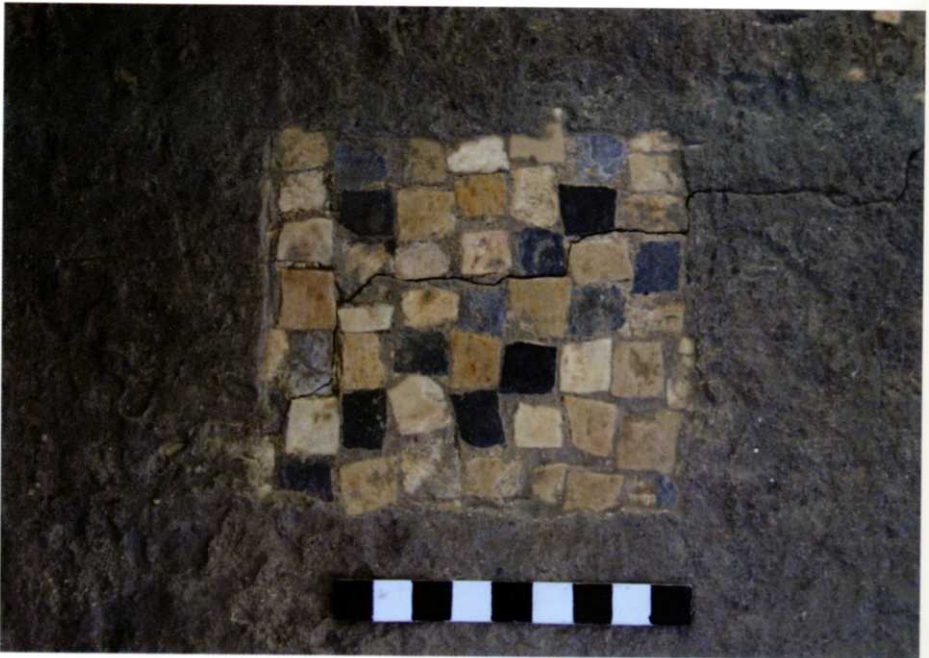
Fig. 5: The removal of a thick layer of dirt from the surface revealed the colours and the decorative pattern of the mosaic.

Frequently, the conservation treatment results in discoveries, which are important from the archaeological point of view. A simple process of removing a thick layer of dirt covering the surface of a mosaic usually reveals details of the colours and patterns of the pavement. This, of course, contributes significantly to the archaeological interpretation (Fig. 5).

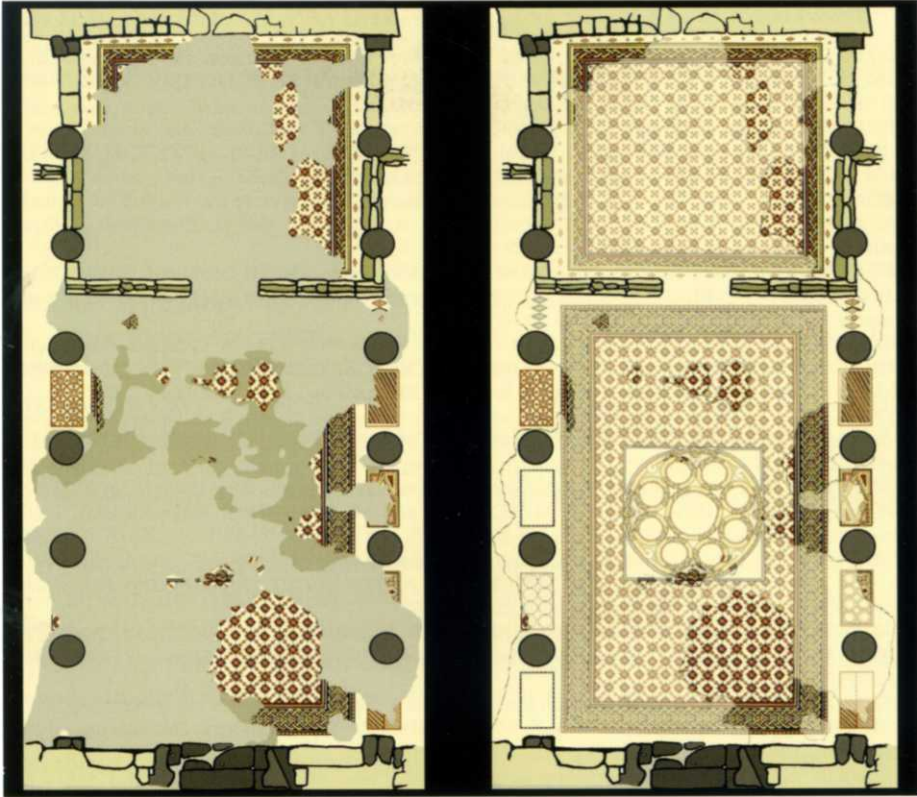
Fig. 7: Left: A plan recording the remains of the mosaic in the nave of the North-West Church worked out in a computer graphic program; and right: the digital reconstruction of the entire mosaic decoration (Julia Burdajewicz).

lost tesserae. The examination of these imprints allowed us to retrace both the extent of the panel and the general design of its pattern. After defining the corners of the roughly square panel by analysing the tesserae imprints in the bedding, it became clear that its dimensions were 3.14 x 3.05 m. The medallion, inscribed in the panel, was composed of an interwoven two-strand guilloche and a torus cable. This interlace must have created eight smaller circles and, most likely, a large circle in the centre of the medallion. Unfortunately, the motifs filling the corners and the circles of the central composition in the North-West Church will remain unknown. Taking into consideration the general stylistic trends of the floor decoration, it is most likely that geometrical or simple vegetal motives were used there too. A commemorative inscription may have been inserted in the central field of the medallion – but, unfortunately, nothing survives.

A general plan of the mosaic floor and the patches of the mortar bedding were drawn in order to illustrate the fragmentary state of its preservation. Then the plan was digitised and worked out in a computer graphic programme. This, together with information gathered on the site allowed us to create a digital reconstruction of the decorative pattern. A number of questions concerning the pavements of the North-West Church still remain unanswered; however, the cleaning and examining of the mosaic and the remains of its bedding, supplemented with digital mapping, gave us some new ideas about the composition of its mosaic decoration (Fig. 7).

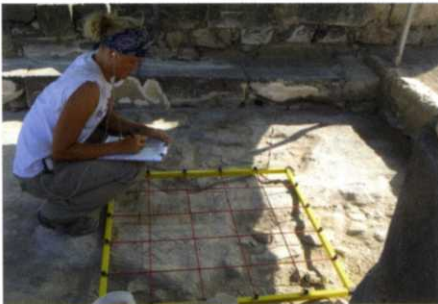
Fig. 6: A volunteer learning how to prepare hand-drawn plans of the mosaic fragments preserved in the North-East Church.

Most of the excavators are inexperienced volunteers. Every season, the professional conservators provide the basic practical training for all those directly involved in the protection and maintenance of the mosaics (Fig. 6). The conservation programme, as well as the choice of materials and tools, is based on locally available supplies.

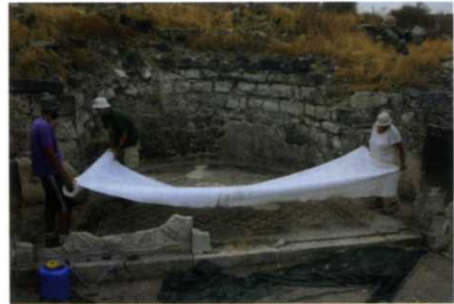
Fig. 8: At the end of each season the mosaics are covered with geotextile and a thick layer of clean sand. Due to the popularity of the site among locals and tourists this kind of protection very often proves insufficient since visitors often uncover the mosaics and then leave them exposed to the elements of nature.

All the mosaics explored at the site of Hippos are being seasonally uncovered in order to check their condition and, if necessary, to resume the conservation treatment. At the end of every season, the mosaic floors are covered with geotextile and a thick layer of clean sand (Fig. 8). Even though this action is carried out with great care and precision, the reburial of excavated structures is only a temporary solution.

As mentioned above, the excavation period lasts for only four weeks each summer; and during the rest of the year the site of Sussita is not permanently guarded. Even though the mountain of Sussita and the surrounding area have already been included into the network of the National Parks of Israel, the site is not officially open to the public. Yet many visitors keep strolling around the area, admiring the ancient structures. Frequently, they uncover parts of the reburied mosaics and then leave them exposed to the elements of nature. Considering the great popularity of Sussita among the inhabitants of Galilee, as well as foreign tourists, it would be a reasonable step to adapt the site as a tourist attraction. As far as the mosaics are concerned, if such a decision were taken, it would certainly be necessary to design and introduce a proper drainage system, suitable roofing and a permanent condition control.
