# PRZEZ GRANICE CZASU

Księga jubileuszowa poświęcona  
Profesorowi Jerzemu Gąssowskiemu

## BLESSED WINE: A NEWLY DISCOVERED WINERY AT THE NORTH-WEST CHURCH IN HIPPOS – SUSITA (ISRAEL)

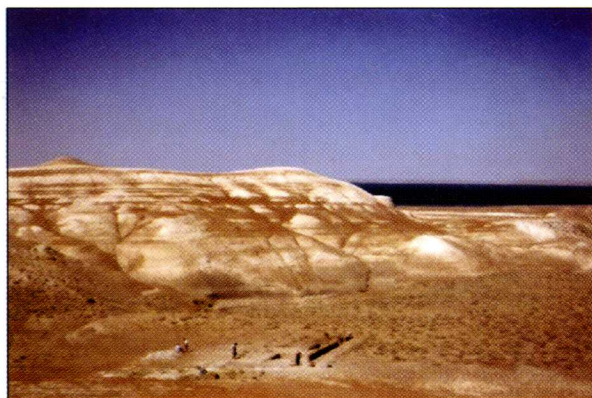
Fig. LXX. A general view from the East on a plateau with Ayakagytna 'The Site'. Further to the West – the Ayakagytna depression with a lake. Photo L. Słowicki.

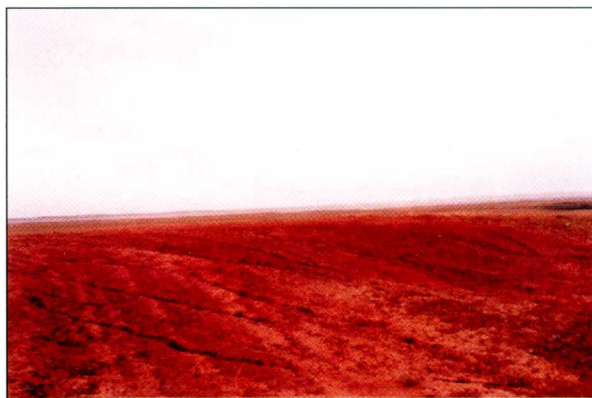
Fig. LXXI. An example of natural outcrops of mineral red ochre, some 1 km West of Ayakagytna 'The Site'. Photo M. Przeździecki.

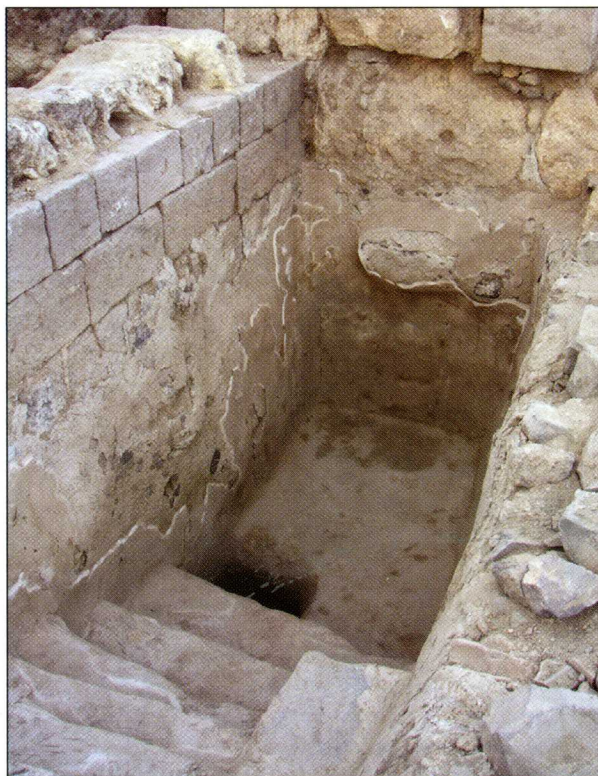
The eastern extremity of the winery is occupied by a collecting vat (L776), which is a narrow (1.60 m) and deep (1.92 m) stepped pool (**fig. LXXII**). Its walls are coated with a double layer of waterproof plaster, the lower one incorporating body sherds of cooking pots and storage jars of local Byzantine/Umayyad types. The length of the vat (4.90 m) equals the width of the northern wing. On the east, it is delineated by an earlier Roman wall (W769), apparently the eastern precinct wall of the *temenos*, a section of which was also re-used as the eastern wall of the basilica. Built of basalt ashlar, this wall is crowned with a single layer of limestone headers. Their extremely weathered condition proves that this eastern wall of the winery did not support any roof at all. The southern side of the collecting vat is in its upper part the same as the outer wall of the northern sacristy of the church (W237). A protruding part of the wall, its structure completely concealed under the hydraulic plaster of the pool, doubtlessly is the foundation part of the basilica's northern wall.

A flight of eight plastered steps descends from the northern side down to the bottom of the vat. The plan of the topmost step is eloquent proof of a very late construction date of the installation: the stones of the northern border do not even form a straight line as if they were put haphazardly onto the place. There is no threshold, nor any traces of an organised entrance to the pool. The second and the third steps are just 1.10 m wide to accommodate a sort of a short intermediate step constructed on their eastern side. The fourth step corresponds to the width of the vat (1.60 m); the next two steps, however, are shorter again (ca. 1.20 m). On their western side, abutting the pool's wall, there is another square socle: a monolithic basalt block plastered all over. It is situated 0.50 m below the outlet of a channel leading from the treading floor (**cf. fig. LXXII**). And again, the length of the seventh and eighth steps corresponds with the width of the vat. At the foot of the steps, in the north-east corner of the floor, there is a settling pit, roughly cubic in shape (0.60 m to a side). A major part of the vat must have been cut in the bedrock; however, the transition point between the constructed part and the rock-cut one is concealed behind the waterproof coating of the vat.

Fig. LXXII. Must collecting vat of the winery as viewed from the north. Note a socle on the right and the settling pit at the bottom. Photo J. Młynarczyk.

It is clear that three methods of extracting the must from the grapes were used on this platform (cf. fig. LXXII). At first, the grapes were trodden barefoot and crushed with the use of the rollers (re-used column drums of basalt) such as those still used in the pressing installations of the Hauran.<sup>11</sup> After that, the grape skins and stalks were gathered and the screw press was used to extract the remainder of the juice. Representations of a screw press in action are known from several mosaic floors in the Byzantine Levant, dated between the mid-6<sup>th</sup> and early 8<sup>th</sup> century.<sup>12</sup> The type of our press (screw-press with

Before the must reached the bottom of the collecting vat, it probably had to be sieved to remove grape stalks and skins. Apparently, this was the function of the western socle built right under the outlet of the channel (cf. fig. LXXII). It is logical to assume that this was the proper spot to place a strainer, possibly of the type of the Roman *colum* made of soft basketry.<sup>15</sup> The next purifying of the must by separating its residue was ensured by the settling tank cut in the vat's floor at the bottom of the steps. According to Talmudic sources such as *Tosefta*,<sup>16</sup> the first stage of fermentation, carried out in this collecting vat, would continue for three days before the must could be transferred to wine jars. At this stage, the eastern socle in the upper part of the steps could have been used. It would have provided a support for large vessels when it was time to fill them with fermented must drawn from the vat and to transport them to the second fermentation place.

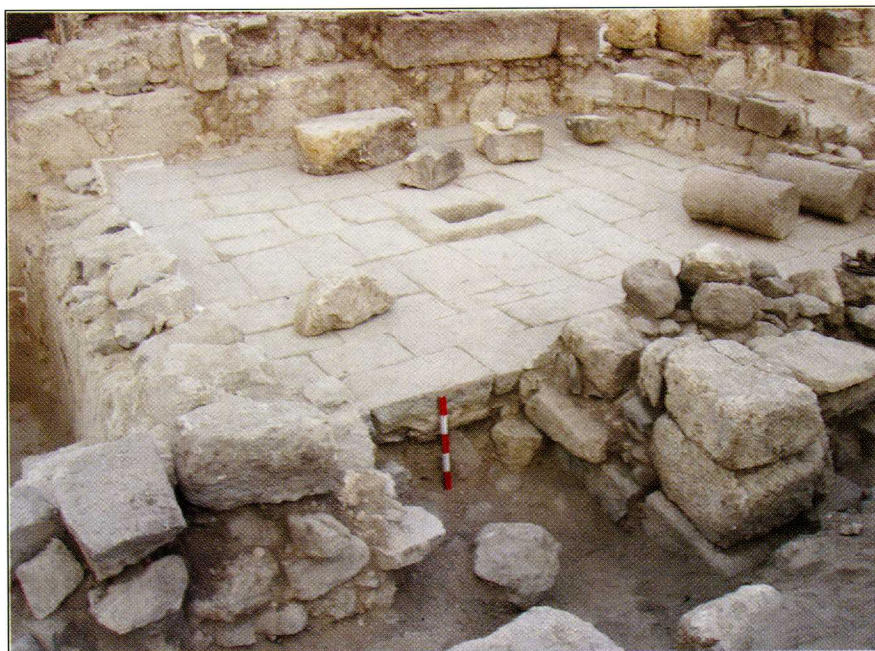
The treading floor (L775) adjacent from the west (**fig. LXXV**) is approximately square in outline (between 4.40 m and 4.70 m to a side). The eastern and western walls are constructed of basalt stones with only one side dressed, that facing the treading floor. Of the eastern wall (W774) just a single layer of masonry (0.36 m high) has survived, while the western wall (W781) preserves two layers of masonry (0.62 m high). Obviously, they were not much higher than that. The northern, outer wall (W245), built of irregular basalt stones, survives to the height of 0.53 m above the treading floor. The floor itself is constructed of rectangular basalt slabs of varying dimensions. Some of the slabs are marked with single engraved letters (*e.g.* O, K) like the flagstones of the *agora* square situated ca. 25 m to the south from the church.<sup>6</sup> In the centre of the pavement there is a rectangular press-bed with a dove-tail mortice for a screw device, placing our installation with type T 831 (Single Fixed-Screw Press, Closed Dovetail Mortice) according to the classification of winepresses by R. Frankel.<sup>7</sup>

west corner to 127.38 m at the north-east corner) towards an open channel, actually an inverted roof-tile of the *imbrex* type, emptying into the vat. Two drums of small basalt columns (0.38-0.39 m in diameter, 0.71-0.73 m long) were found on the treading floor, doubtlessly used as rollers while crushing the grapes.

Fig. LXXIII. Treading floor of the winery as viewed from the north-east. Note two column drums used as rollers and a damage done to the northern wall by a modern military trench. Photo J. Młynarczyk.

The way of entering the winery complex from outside remains a mystery, as no traces of any entrance have been preserved in the northern wall (W245), built mostly of irregular basalt stones. As a matter of fact, a section of this wall has been severely disturbed by the military trench (**cf. fig. LXXIII**). The height of the wall in question cannot be ascertained, but it sounds logical that it was rather low with the open-sky rooms (collecting vat, treading platform, twin storage compartments and the narrow “corridor”). It is only in the fermentation hall that the northern (outer) wall was high enough to support a partial roofing. It is rather logical to assume that the entrance was situated close to the twin storage compartments, because it was there that the grape stuff was being unloaded and preparation of wine was beginning. The access could have been provided by a wooden footbridge thrown across the northern wall.

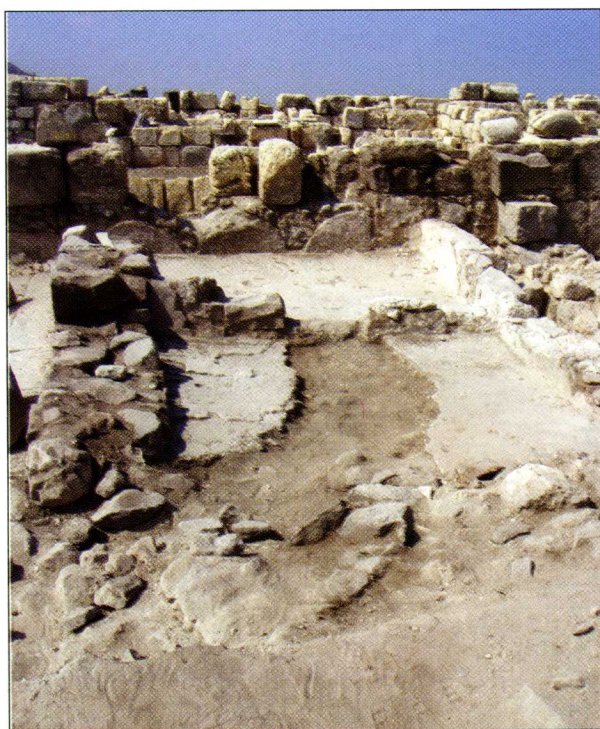
In the south-western corner of the treading room, a plastered entryway 0.76 m wide leads to the northern one of twin compartments (L782 and L783), adjoining on the west (**figs. LXXII-LXXIII**). These roughly square compartments were entirely revetted with two successive layers of white plaster rather than hydraulic mortar. The southern compartment (L782) measures inside 2.15-2.20 m from north to south and 2.30-2.45 m from east to west. Since its floor is slightly higher than that of the treading floor, they are separated from each other by a sort of “threshold” in the entryway, 0.16 m high. The eastern wall is preserved to the height of 0.50 m above the compartment’s floor, and its original height remains unknown. A low partition wall, just ca. 0.30 m wide, separates L782 from the northern square compartment (L783). This fence, 0.35 m high, its top rounded and thoroughly plastered, has partially been destroyed by a military trench. The western “wall” has the same height of 0.35 m above the floor, and its plastered top is squarish. The floor slopes slightly to the north-west, towards an oval-sectioned opening (0.16 m high) in the western wall.

The northern compartment (L783) is slightly smaller than the southern one; its inner dimensions being 2.05-2.10 m from north to south, and 2.20 m from east to west. It has been severely damaged by the military trench, so the walls have been preserved to an insignificant height and the central section of the floor has completely been destroyed (**fig. LXXIV**). Like in L782, the floor slightly slopes from the south-east corner towards an oval opening in the western wall.

Fig. LXXIV. Twin compartments of the winery as viewed from the north. Note the traces of the modern military trench left on the floor of the northern compartment. Photo J. Młynarczyk.

The wine processing was beginning in the twin plastered compartments (cf. fig. LXXIV), which clearly were destined for prolonged storage of the grapes. This was the method of producing free-running juice or “first must” (*prototropum* of Pliny 14,12,85, *mustum lixivium* of Columella 12, 41) to ensure sweeter kind of wine. In the Talmudic sources such wine is mentioned as *hylstwn*, from Greek *heliaston*, “of the sun”<sup>9</sup> and indeed, according to an earlier source, Roman agronomist Columella (12,27), this kind of sweet wine (*vinum dulce*) was obtained when the grapes were left in the sun for three days.

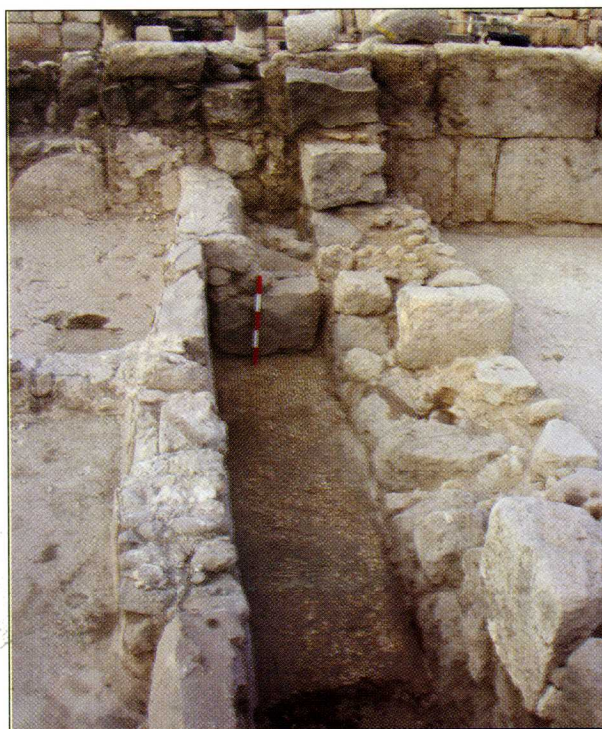
The two openings in question lead from the twin compartments to a narrow sunken space on the west (L780), its floor level lower by 0.33-0.40 m. This is the western part of an earlier mosaic-paved room (F785), originally connected with the northern aisle of the basilica by a door (**fig. LXXV**). After the door was sealed, the twin storage compartments were constructed upon the mosaic floor (with its very simple linear ornaments), leaving a sort of a corridor just 0.60-0.65 m wide. The southern end of this “corridor” is occupied by a solid platform (L784), built of small stones and roughly plastered on top; it abuts the sealed door in the wall of the basilica.

Fig. LXXV. Service "corridor" between the twin storage compartments (on the left) and the fermentation room (on the right). Note an earlier mosaic floor, a stone platform at the southern end, and the blockage of the door once connecting the northern wing with the basilica. Photo J. Młynarczyk.

This first must, dripping rather than flowing out of the grapes, doubtlessly was collected into pottery vessels placed under the two outlets in narrow compartment L780 (cf. fig. LXXV). The vessel form suitable for this purpose appear to be “craters” (deep basins) rather than jars, the former being more stable and fairly wide-mouthed so as not to waste any single drop; the distance between the outlets and the corridor’s floor (0.33–0.40 m) was ideal to place such vessels there. Actually, similar vessels are still being used in the present-day grape-presses of the Hauran.<sup>10</sup> On the east side, the elevated threshold between the southern storage compartment and the treading floor prevented the juice of stored grapes from getting mixed with the juice of the grapes trodden and pressed on the basalt platform. Only after the required amount of the first must had been collected, the grapes were transferred from the storage compartments onto the treading floor.

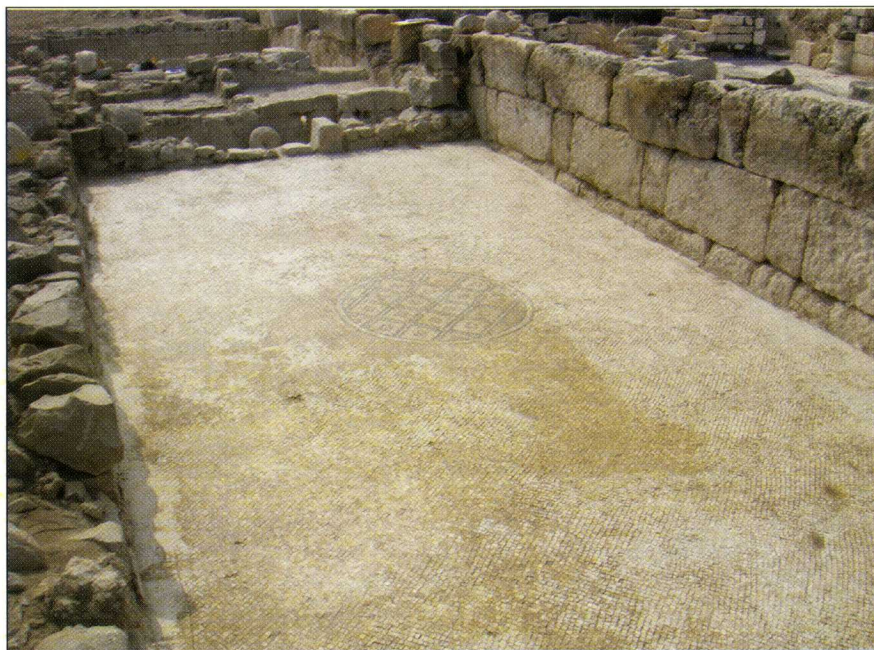
The room is paved with a well-preserved mosaic (F768, **fig. LXXVI**) made of large cubes (1.4-1.7 cm to a side). The mosaic is plain except for a medallion (Diam. 1.40 m) situated in the centre of the room. It is filled with a simple geometrical ornament of diagonal grid with diamonds in the hues of grey, black and brownish red against the background of white- and cream-coloured tesserae. The floor slopes from the

maximum elevation 127.41 m above sea level in the north-east corner to 127.11 m in the south-west corner, towards a gap in the mosaic, framed by a multiple row of tesserae. In this intentionally unpaved corner of the room, a small horseshoe-shaped plastered basin (L777) was discovered, its bottom 0.32 m below the level of the mosaic. It apparently served as a sort of a sink, a collector for liquids.

There is evidence that the hall had only a partial roofing. In its western part, a layer of debris contained broken roof pieces, ca. 0.12 m thick. They were composed of three distinct layers: pieces of terracotta tiles, mixture of clay and mortar with ashes and tiny pebbles, and pumex stones coated by a thin layer of mortar on the top. In the eastern part of the room, however, the mosaic floor was instead covered with a whitish layer of crushed clay with lime mortar. This would suggest two different systems of the roofing, each corresponding to a limited space, as if a sort of verandah. In addition to this, a partial wooden roof (a sort of gallery?) ca. 1.50 m wide was protecting the area along the northern wall, to judge by the imprints of wooden beams left on the mosaic floor.

Fig. LXXVI. Fermentation hall of the winery as viewed from the west.  
Photo J. Młynarczyk.

There can be little doubt that the second fermentation, which in this region should have lasted at least 40 days,<sup>17</sup> was taking place in the mosaic-paved hall (cf. fig. LXXVI). The must would be stored there either in *pithoi* (*dolia*) or in jars (amphorae). The *dolia* should have been covered by lids;<sup>18</sup> the narrow-mouthed jars could probably stay open or protected by a piece of fabric. This stage of the fermentation required frequent stirring and removing of foam. The slope of the floor towards a "sink" in the south-west corner ensured the controlled removal of the foam, while the durable waterproof mosaic floor, easy to clean, helped to maintain hygienic conditions. It is certainly interesting to note that here the fermentation process was carried out in rather high temperature (provided it was happening throughout late September and October) instead of in cool and dark conditions. Indeed, S. Dar<sup>19</sup> has expressed the view that some kinds of wines might have "preferred" the warm rather than cold atmosphere.

The central ornament of the mosaic in the fermentation hall (**cf. fig. LXXVI**) is best paralleled by a number of the Umayyad-period mosaics in the area ranging from the eastern Galilee to Moabitis, such as found in Tiberias and attributed to the end of the Umayyad or the early Abbasid period,<sup>22</sup> in the church of Virgin Mary at Madaba dated to the 8<sup>th</sup> century,<sup>23</sup> a mosaic of A.D. 717/18 in the lower church of al-Quwaysmah,<sup>24</sup> and mosaics in Qastal.<sup>25</sup> The same simple motives, to be true, occur also in several earlier floors, *e.g.* in the church of St. Peter at Khirbat as-Samra, dated ca. 637.<sup>26</sup> Poor execution and simple construction methods in individual parts of the winery (such as the use of a ceramic *imbrex* to flow the grape juice to the collecting vat) point to a somehow makeshift character of the winery, installed in the northern wing as if because of a sudden need. To sum up, one is inclined to believe that this winery was not a long-lived one, therefore its establishment could even be as late as the first half of the 8<sup>th</sup> century.

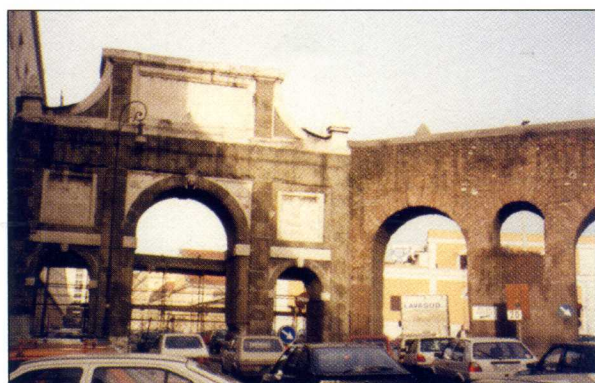
Ryc. LXXVII. Łuki Aqua Marcia przy Porta Triburtina. Fot. M. Biernacka-Lubańska.

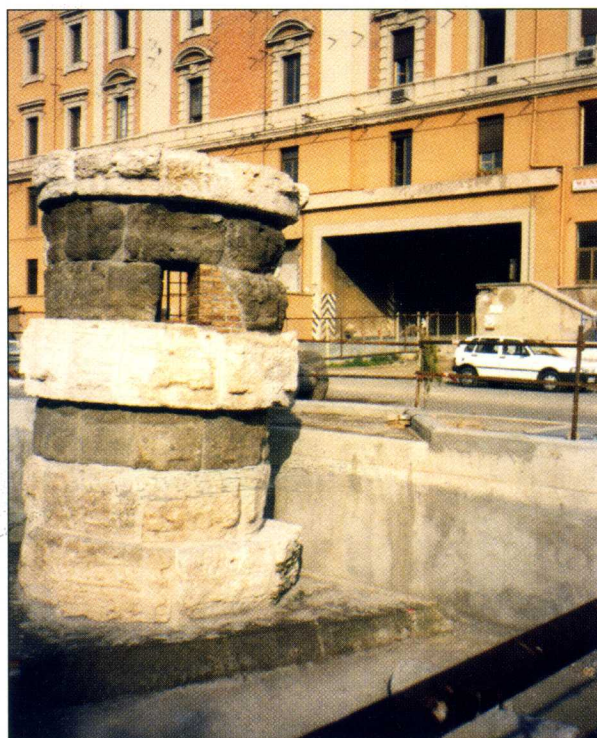
Ryc. LXXVIII. Dzielnicowy zbiornik rozdzielczy Aqua Marcia przed dworcem kolejowym Roma Termini. Fot. M. Biernacka-Lubańska.
