MANAGING ARCHAEOLOGICAL SITES WITH MOSAICS: FROM REAL PROBLEMS TO PRACTICAL SOLUTIONS

THE 11TH CONFERENCE OF THE INTERNATIONAL COMMITTEE
FOR THE CONSERVATION OF MOSAICS, MEKNES, OCTOBER 24-27 2011

MOSAIC FLOORS IN THE NORTH-WEST CHURCH OF SUSSITA: A CASE-STUDY ON TEN YEARS OF A JOINT CONSERVATION AND ARCHAEOLOGICAL PROJECT

Julia Burdajewicz

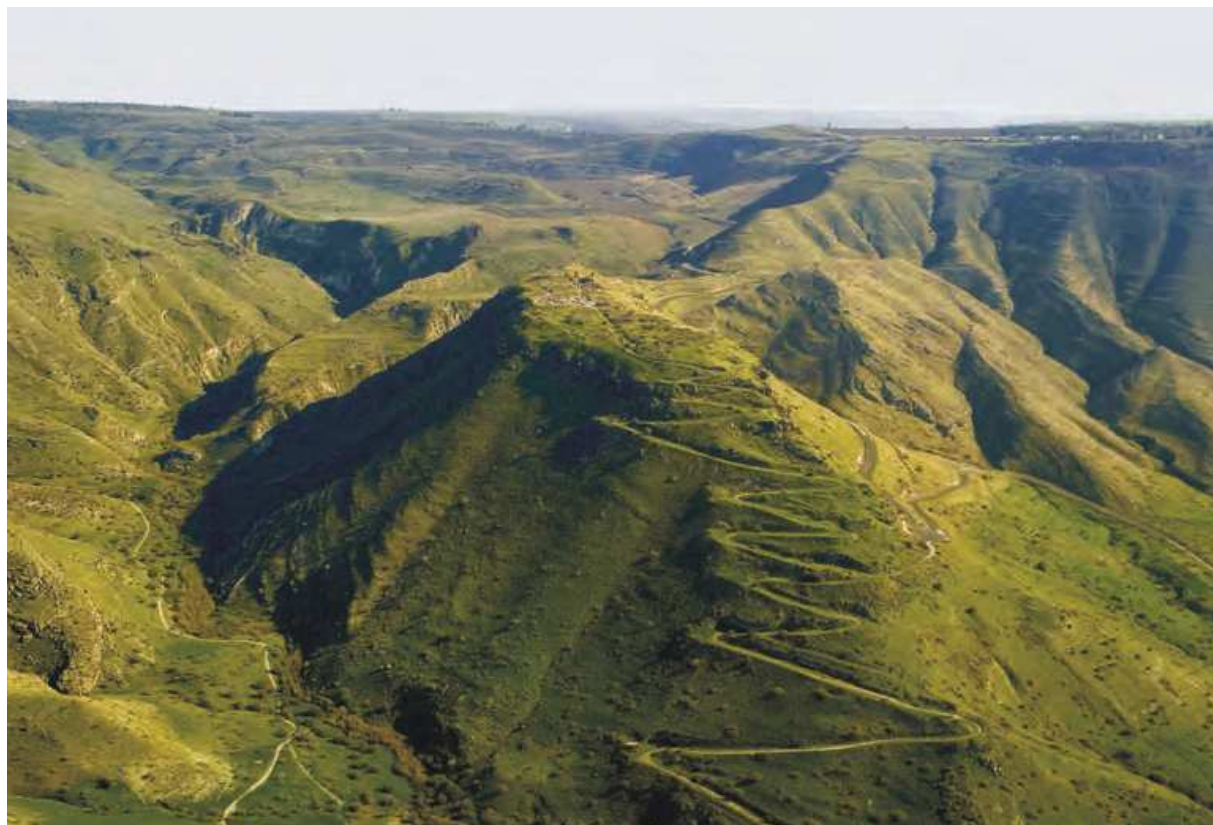
Fig. 1. Aerial view of Sussita Mountain. The site was inhabited between the 3rd century BC and AD 749. The North-West Church seems to be the largest of four churches uncovered so far in Sussita (photo: Zinman Institute, Haifa)

Time limitations did not apply only to the length of the season, but also to the working hours. The site is located on the flat top of a mountain rising around 300 m above the level of the Sea of Galilee (100 m above sea level) (see Fig. 1). The team members had to be transported to the site and back with a bus and had to climb a narrow path on the ridge of the mountain. The beginning and ending times of work were strictly bound to very particular, rigid hours and, due to safety reasons and the difficult weather conditions during the day, no person was allowed to stay on the site beyond working hours. This fact imposed a very particular working mode, where all actions had to be completed before the end of the day, all tools and materials stowed and secured until the next day. Moreover, the difficult accessibility to the site often slowed down the delivery of conservation supplies. Another serious challenge were the weather conditions during the work seasons, which always took place in the month of July, except for the campaign of 2004, which was conducted in September. Temperatures in July in the area of the Sea

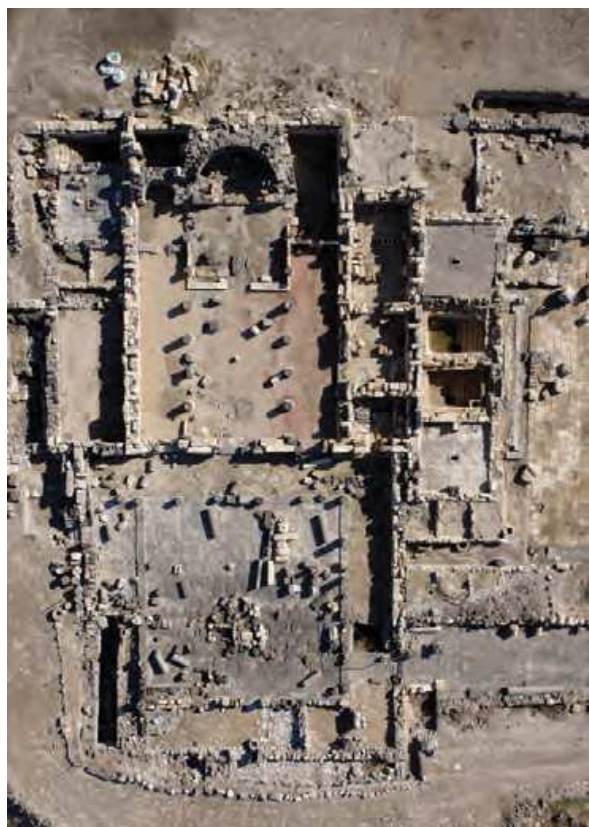
Fig. 2. Aerial view of the North-West Church and adjacent rooms (photo: Zinman Institute, Haifa)

Sussita (Hippos of the Decapolis) (Fig. 1) is located on the east shore of the Sea of Galilee. Founded as a Greek settlement in Hellenistic times, it developed as a city in Roman Imperial times. During the Byzantine period, Sussita reached the peak of its growth and served as a seat of a bishop. Its history, over eleven centuries long, suddenly ended in AD 749 due to an earthquake that sealed the city under layers of stone when it was still inhabited. Except for a short rescue excavation conducted by Claire Epstein in the 1950s, and research on the aqueduct by an Israeli-German team in the 1990s, the site remained unexcavated until 2000 when an international project aimed at uncovering the city was initiated. Within the framework of the Hippos Archaeological Project led by the University of Haifa, the North-West Church in Sussita was excavated in the years 2000-2009 by an archaeological team from the Polish Academy of Sciences, the National Museum in Warsaw and the University of Warsaw, under the direction of J. Młynarczyk and M. Burdajewicz. The goal of the archaeological project was to uncover an Early Christian church, analyse its architectural development and interior decoration, characterize specifics of the ceremonial practices, determine the period of use, and investigate its destiny under Umayyad rule (Fig. 2).

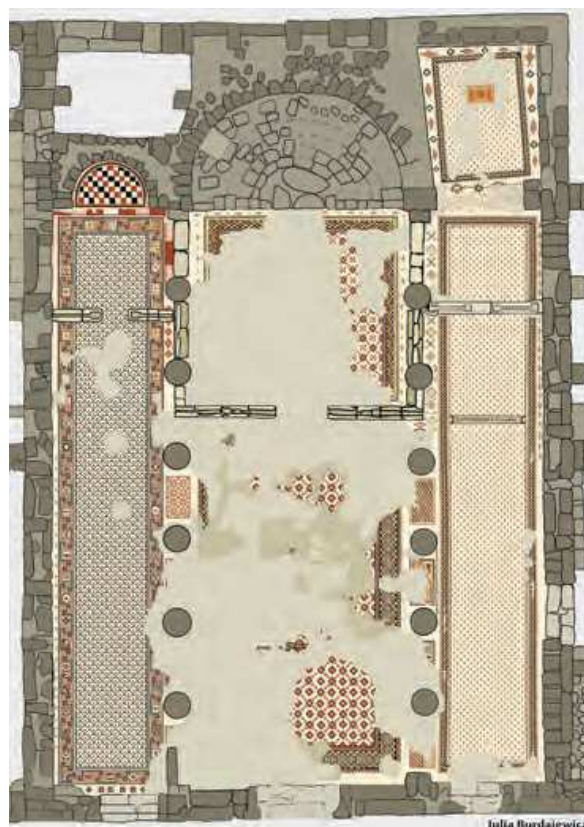
Fig. 3. The surviving mosaic floors in the North-West Church. The graphic documentation was first made as hard-copy drawings and then digitized after the end of a season. Furthermore, a software for the graphic documentation of conservation, metigoMAP, was employed to document the state of preservation and estimate the range of damages (drawing: J. Burdajewicz)

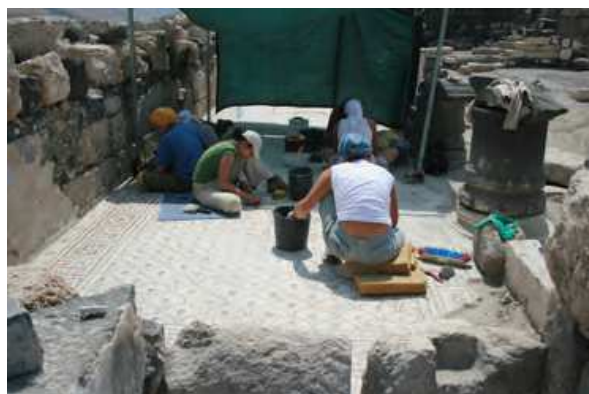
Fig. 4. Graduate students from the Faculty of Conservation of the Academy of Fine Arts in Warsaw performing stabilization treatments to the mosaic carpet in the north aisle of the Church (photo: J. Burdajewicz)

loose tesserae that were found scattered all over the site. It should be emphasized that the conservation team was not formed exclusively for the mosaic conservation but had to share its time between the mosaic floors, the wall plasters, remains of wall paintings and excavated small objects (Fig. 4).

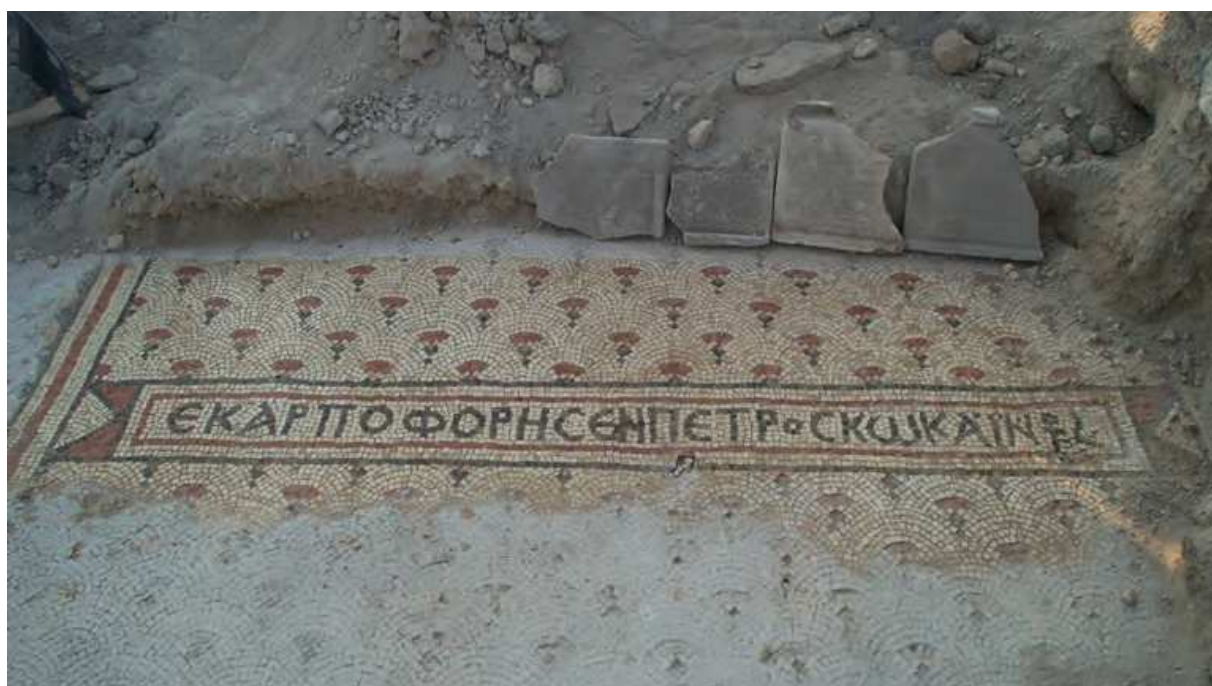
Fig. 5. The mosaic floor in the south aisle of the Church during exploration. Stabilization treatments had to be performed immediately after discovery (photo: J. Burdajewicz)

from its characteristics. One of them was time. A four-week season practically meant 20 days of work on the site, but taking into consideration the time for the installation of the team and the tools at the beginning of each season and packing and clean-up activities on the last day, it did not leave more than 17-18 days for actual conservation activities. In order to make the most of the time given, all actions had to be carefully planned. However, the nature of working in situ during the archaeological exploration naturally imposes unexpected and unplanned actions that have to be taken immediately, every time there were new, sudden discoveries (Fig. 5).

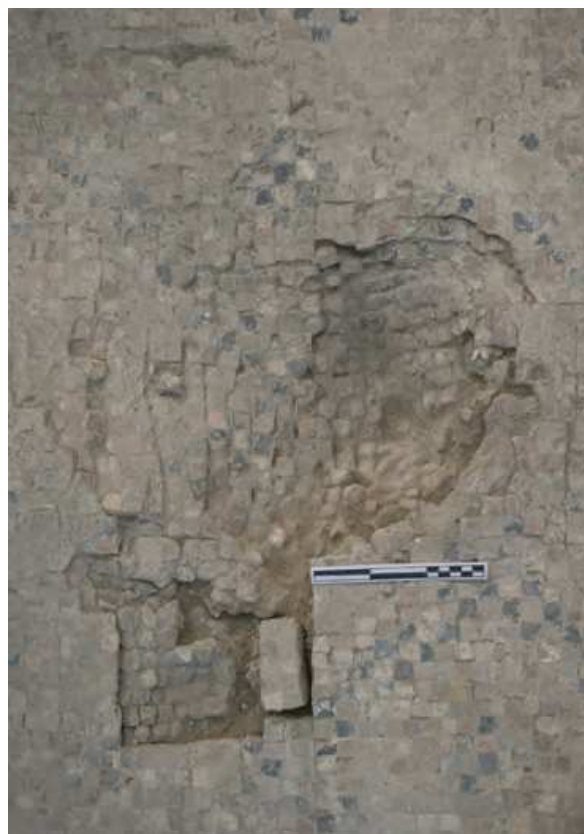
Fig. 6. Serious surface deformation and large lacunae appeared throughout the mosaic carpets as a result of the earthquake of AD 749 (photo: J. Burdajewicz)

The most serious damage to the mosaic pavement occurred when the church collapsed in the earthquake of AD 749. Large blocks of limestone and basalt collapsed on the floors, in many places breaking through them and crushing large numbers of tesserae. This resulted in numerous lacunae in the surface of the mosaics, large indentations and damaged tesserae (Fig. 6). There is almost no mosaic pavement preserved in the nave. Several surviving patches give a total of 22.33 m², which is 22.6% of the entire area of the nave (Table 1). There are two possible explanations for the almost complete lack of the mosaic in the nave. It could have been destroyed in antiquity, perhaps for iconoclastic reasons. However, the discovered remains together with the rest of the surviving mosaic decoration suggest that the decorative motives were purely geometric and floral; hence there was no real reason

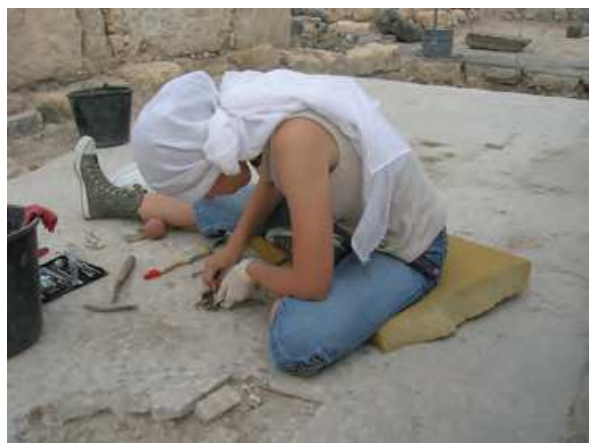
Fig. 7. Some minor aesthetic restorations were carried out in small lacunae. However, due to the character of the works, most treatments were focused on immediate stabilization and preservation (photo: J. Burdajewicz)

Stabilization treatments of the mosaics' structure were focused on the reinforcement of edges around lacunae and securing the losses from expanding. This was achieved by the application of lime-based mortar bands and filling the lacunae. In some instances, minor losses were restored with the use of tesserae collected on the site (Fig. 7). Also, badly eroded tesserae were replaced with better preserved ones. These treatments depended on time limitations and could not be carried out in all of the lacunae. In the case of powdery tesserae, consolidation treatment with a solution of a synthetic resin was carried out. A solution of Paraloid B-72 was applied multiple times to the surface of the weakened tesserae until the desired cohesion was achieved (Fig. 8). Large indentations caused by the collapsing masonry of the church, found especially in the mosaic pavement in the southern portico of the atrium, were brought back to level. This required cutting out a certain area of tesserae, filling

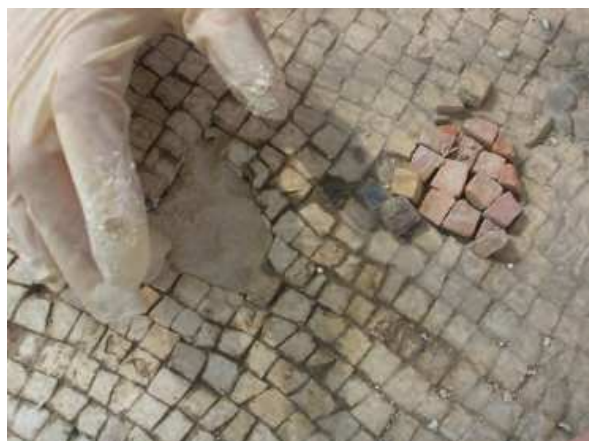
Fig. 9. One of the conservators preparing loose tesserae for replacement where the pavement was smashed by falling stones during the earthquake of AD 749 (photo: J. Burdajewicz)

the gap that appeared in the bedding and then placing the tesserae back with a new lime-based mortar binding. Cracked and smashed tesserae were replaced with loose ones collected on the site (Fig. 9). During the entire course of the conservation campaigns, documentation of the state of preservation and the treatments applied was being made and updated. The main means of documentation were photography and drawings, complemented with notes and reports. Again, due to the short length of the campaign and the difficult working conditions on the site, the drawn and written documentation was made with traditional methods and digitized later, after the end of the season. Also, throughout each season, previously discovered and treated areas were checked and any changes in their condition were recorded. The fact that the site is not properly guarded during eleven months of the year imposed the necessity of a very careful preparation of the mosaic floors for that period. Due to the character of the undertaking, the only available way of securing the mosaics for the rest of the

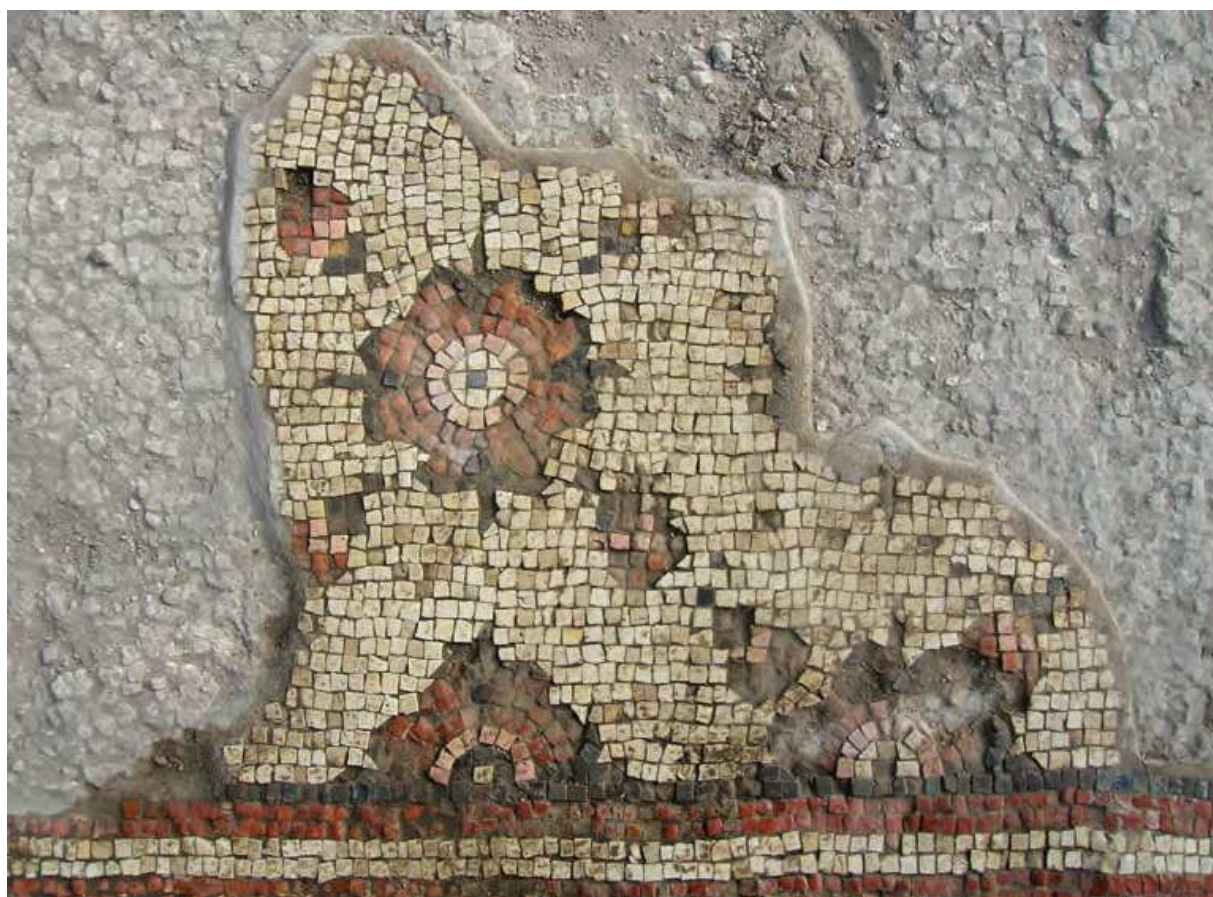
Fig. 8. Many of the colourful tesserae needed immediate consolidation. Particularly those made of soft red and yellow limestone, which were almost completely worn in many areas of the design (photo: J. Burdajewicz)

lacunae were expanding easily due to the fragility and tendency to crumble of the mortar bedding. The technique and quality of execution of the pavements varies slightly in individual areas and indicates that the deterioration problems are occurring mostly in the lower mortar layers of the mosaic bedding, where a poorer quality mortar seems to have been employed. The physical and chemical erosion affected also the state of preservation of the tesserae; especially the red and yellow ones made of a soft limestone, which were very fragile, powdery, washed out or cracked.

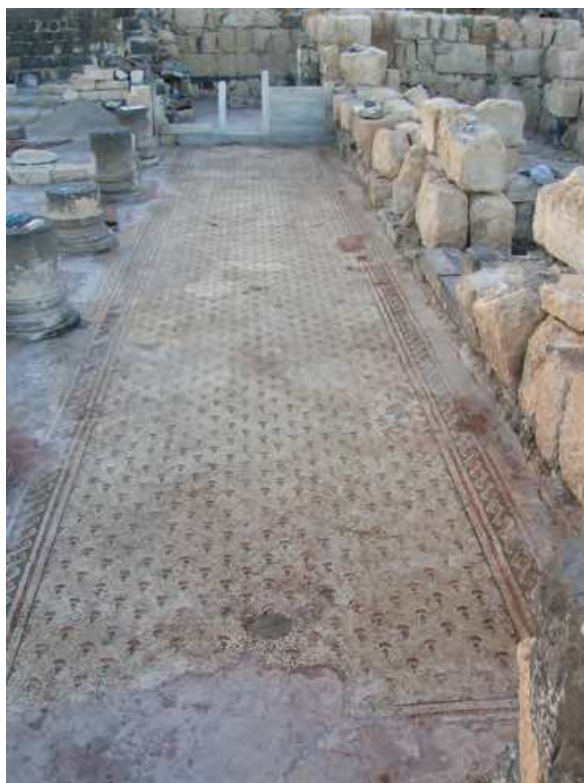
Fig. 10. The North-West Church needs a project for a proper exhibition of the mosaics in their architectural context. An overall plan of opening the site to the public should include a long-term conservation plan and the upgrading of some of the solutions applied during exploration. This will allow the mosaics to speak the site's history (photo: J. Burdajewicz)

fulltime or seasonal exposure of the mosaics. An overall plan for opening the site to the public should include a long-term conservation project and an upgrade of some of the temporary reinforcements applied during exploration. This future project requires also a significant financial input, which could not be provided by the archaeological-conservation team and remains in the hands of the National Parks and Israel Antiquities Authority. However, the goal of the North-West Church archaeological project was achieved with the committed support and assistance of the conservation team (Fig. 10).
